ADDENDUM NO. 4

MENDENHALL 'A' ROOF REPAIRS

FOR: FLORIDA STATE UNIVERSITY

June 30, 2017

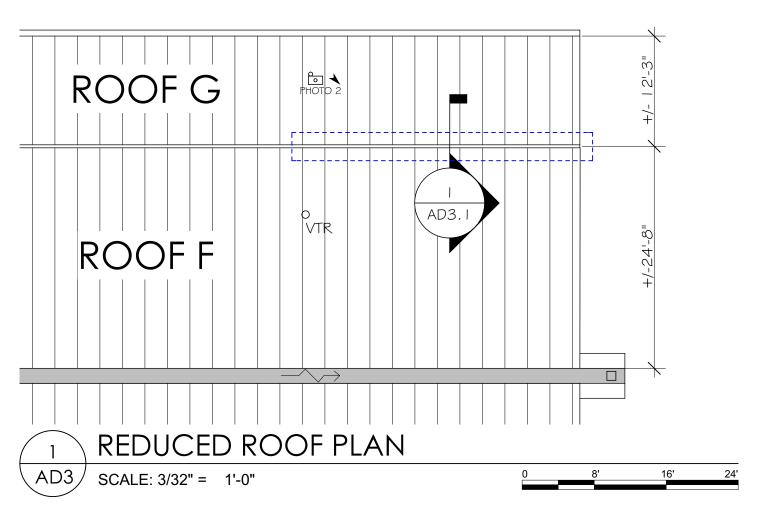
AD4

Partial Reduced Roof Plan Clerestory Window Detail

Contractor to carefully remove **two** section of clerestory window frames (4 panes in each section) above the northern end of Roof G. Remove the deteriorated wood blocking at the sill and replace with new pressure treated 2"x 4" blocking and new stainless steel 3/8" anchors bolts, counter sunk. Reinstall salvaged clerestory window frames into existing opening with new stainless steel anchors. Clean, prime and paint window frames and seal window frames and panes perimeter with premium silicone sealant, as detailed.

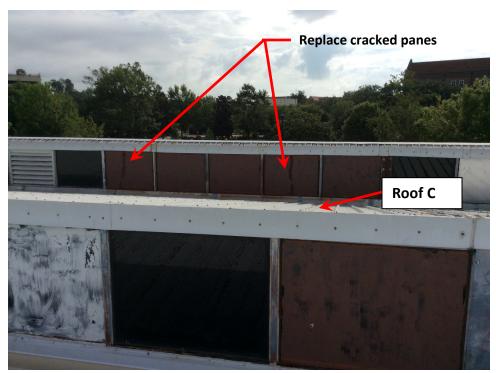
Addendum 4 – Photo #1

Contractor to replace broken/cracked clerestory window panes (2) above the narrow low slope roof of Roof C, that have been sealed with sealant and painted over (brown paint) with new panes, size and thickness to match existing. (See photo attached) Seal the perimeter with silicone glazing, as required.

Contractor to provide unit cost to remove clerestory window panes and replace with new. \$__/ pane.
