### **Landscape Architectural Design Guidelines Supporting Data**

#### **1. Inventory and Analysis of Existing Conditions**

#### **1.a. An inventory of the existing character, quality and location of landscape treatments on the Main Campus are as follows:**

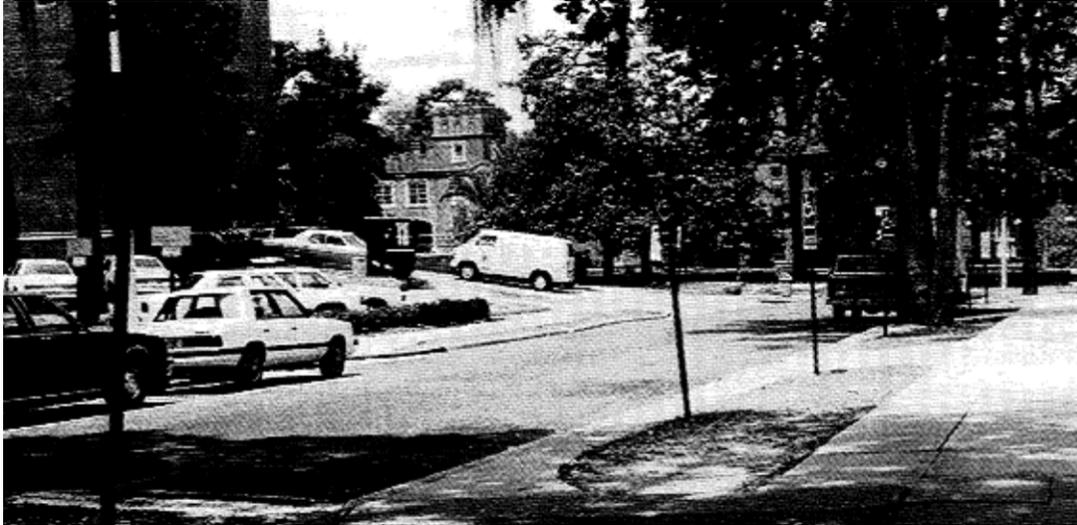
**Photo 16.1**      **Vehicular Circulation; University Way**

- a) Some have curbs, grass, some trees, and a sidewalk. See **Photo 16.1**.
- b) Some have curbs, grass, and some trees. See **Photo 16.2**.
- c) Some have sidewalks and curbs. See **Photo 16.3**.
- d) Some have curbs, some grass, some walks, some parking and few trees. See **Photo 16.4**.

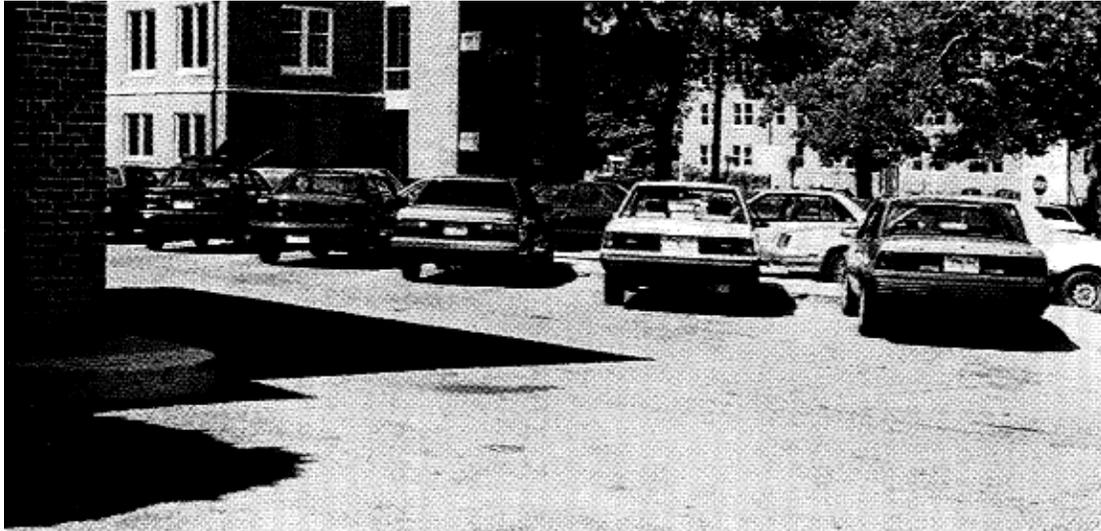
**Photo 16.5**      **Parking; Typical Small Asphalt Paved Lot**

- a) Some are small paved with asphalt, and not too visually imposing. See **Photo 16.5**.
- b) Some are located adjacent to and part of a campus street. These tend to have a strong visual impact. See **Photo 16.6**.
- c) Some are large, asphalt lots that, depending on their organization, orientation and visibility, vary in their visual impact. See **Photo 16.7**.
- d) Some are unpaved or paved with gravel, relatively organized and amongst large existing trees. See **Photo 16.8**.

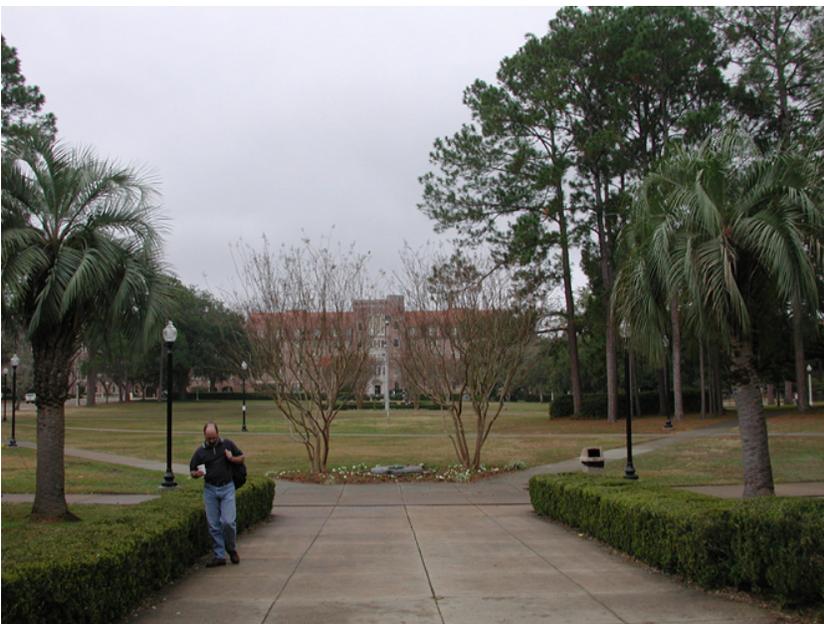
**Photo 16.12**      **Pedestrian Circulation; Desire Lines**

"Desire lines" (high volume paths worn into lawn or planted areas) are the prim indicator of inadequate walk distribution or width and an important way to learn of unanticipated routes. See **Figure 16.2** and **Photo 16.12**. In past years, the Physical Plant Department says it has constructed 2000 linear feet of walks on average each year which addresses "desire lines" and general walk maintenance.

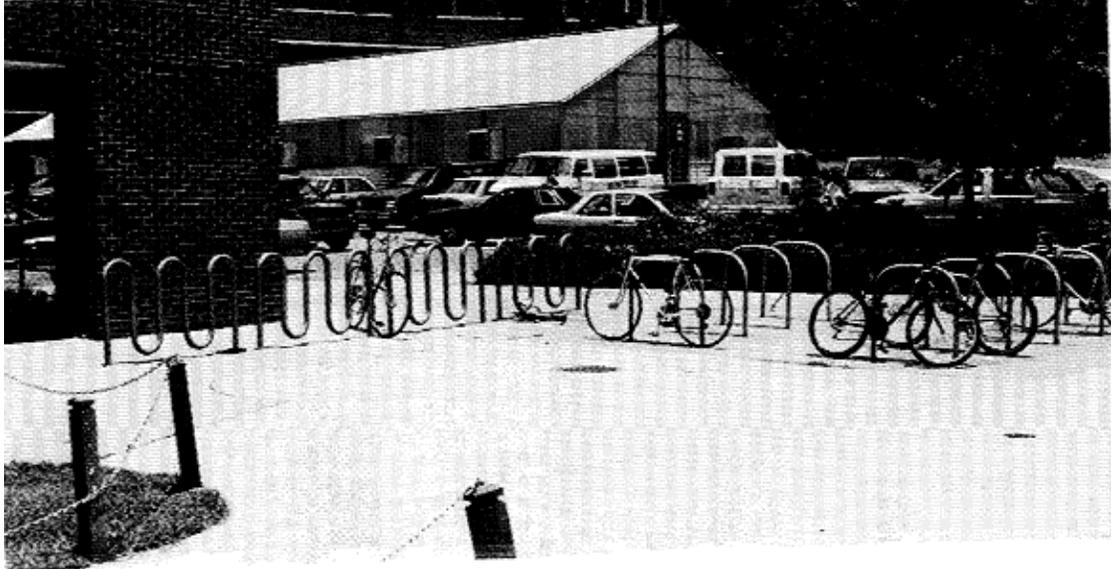
**Photo 16.13**      **Bicycle Parking Facility; Two Types, One Location**

- a) Bicycle Parking Facilities, as shown in **Figure 16.3**, bicycle-parking facilities are located throughout campus. At least five different types of bicycle racks are currently to be found, with the simple hoop the most prevalent and most popular. Bikes have also been observed chained to fences, trees, railings and signposts. See **Photos 16.13** and **16.14**.

1. Bicycle Facilities: Bicycle facilities are distributed across campus, and apparently are heavily used. There are five different types of bike racks on campus with only one being fully utilized by students; the high pipe hoop. However, the high hoop is not located everywhere and if given a choice by students, all other racks would be ignored. Therefore, all other racks should be removed and replaced by high hoops to eliminate the visual clutter created by the unattractive, unused racks. See **Photo 16.4**.
2. Benches: Benches occur in multiple styles and nearly all are without backrests. Project-specific benches, designed as part of a space such as those adjacent to the fountain at Landis Green can and should occur.

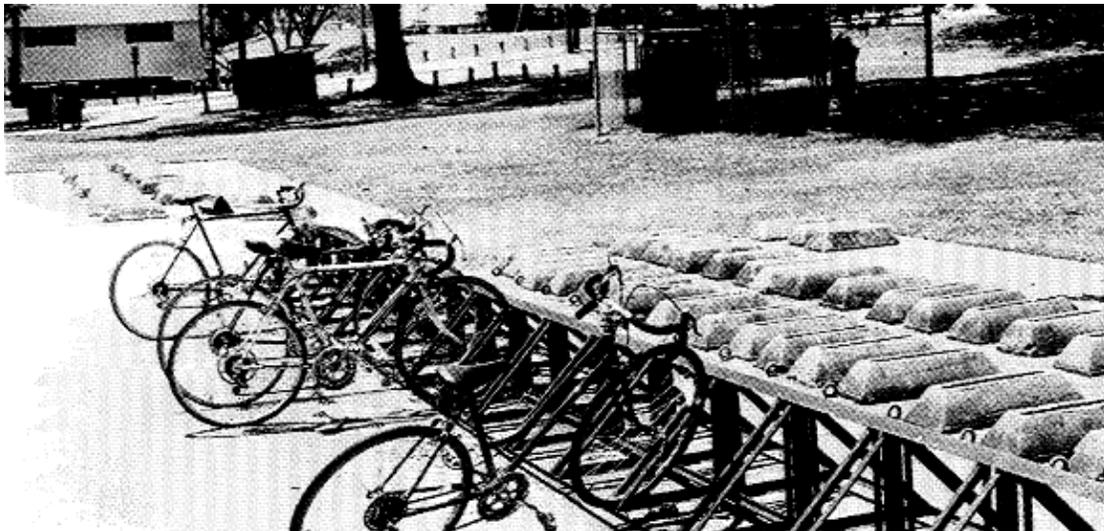
**Photo 16.14**      **Bicycle Parking Facility; Two Types, One Location**

4. Concrete:  
The precast concrete bike racks require little or no maintenance. See **Photo 16.14**.
  5. Triangular Steel Frame:  
The triangular steel racks require a little more maintenance than the concrete racks due to rusting. See **Photo 16.14**.

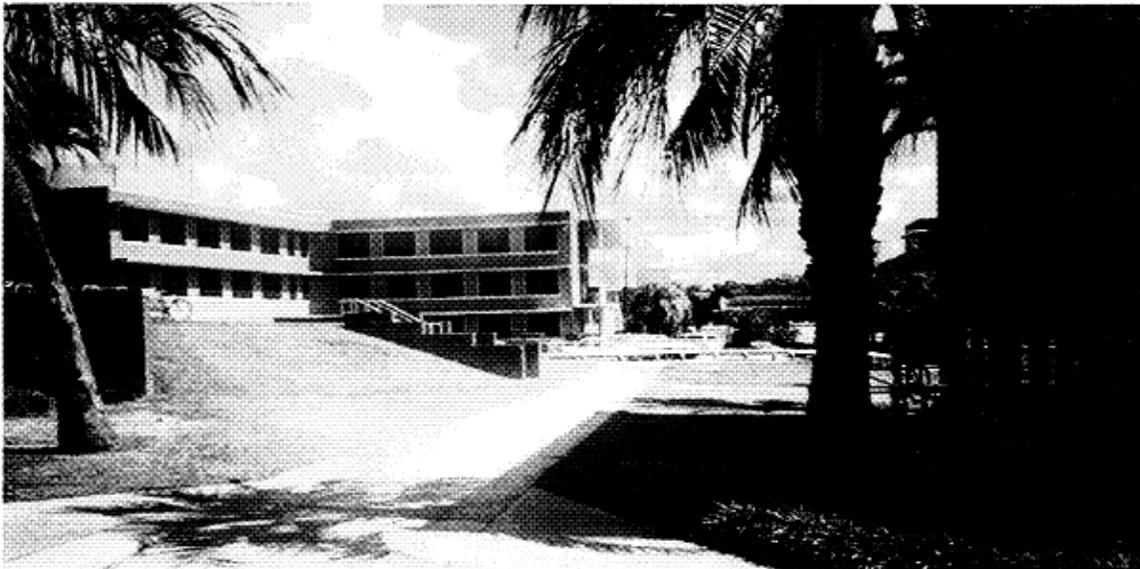
**Photo 16.18 Existing Planting Areas; South of the Love Building**

**1a.7 Planted Areas:** As shown on **Figure 16.5**, nearly all of the Main Campus ground are improved and maintained landscape comprised predominantly of lawns and tree with the dominant tree species being Live Oaks and Slash Pines. In the older parts of campus, east of Woodward Avenue, a substantial amount of shrub materials exist as foundation and accent planting. See **Photo 16.17**. Newer parts of campus have few shrub masses, depriving the spaces of layering and scale. See **Photo 16.18**.

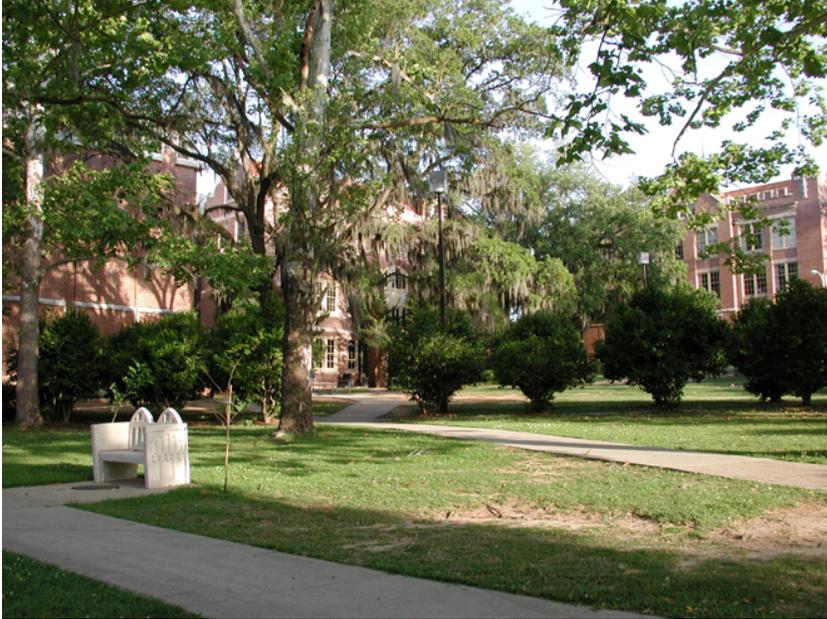
**Photo 16.19** Existing Planting Areas; Mina Jo Powell Memorial Green

The Landscape Visual Quality Analysis, **Figure 16.10**, is largely derived by the positive or negative influence the landscape has on the viewer. The richer more varied spaces have a high visual quality, see **Photo 16.19**, and are more appreciated spaces on campus than relatively barren landscape as found in the northwest corner of campus. See **Photo 16.18**. Campus landscape enhancement should focus on upgrading the northwest area giving it scale, texture and layering.

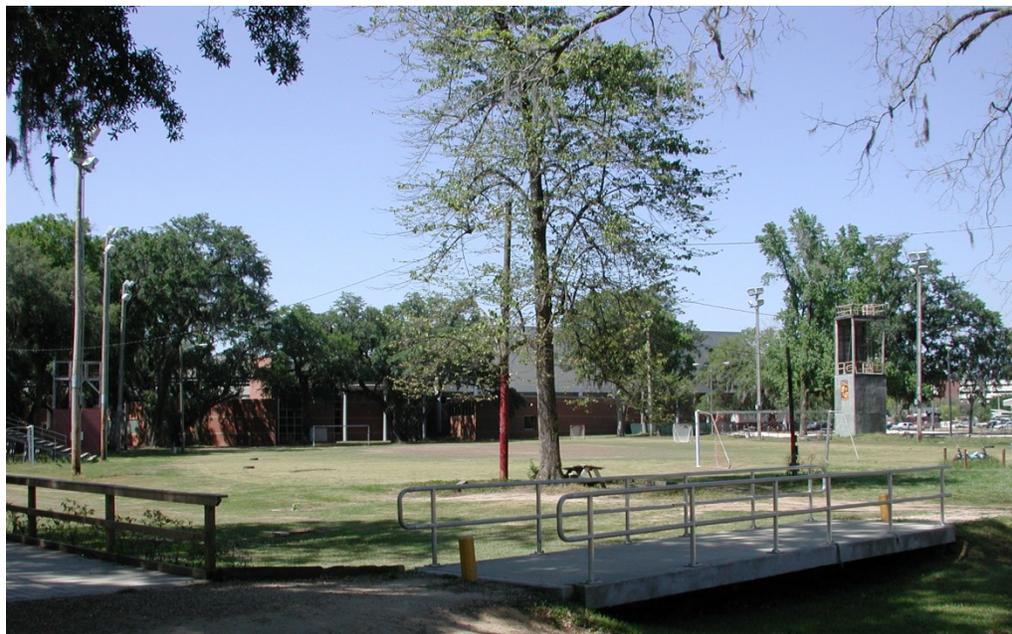
**Photo 16.20** Existing Planted Areas; Unmaintained Landscape East of the Circus

Only a very small portion of the Main Campus exists in an unimproved but maintained condition. That area, as indicated on **Figure 16.5**, has many large trees and the central drainage channel. Some of the area is currently used for parking under the trees. The "Big Tree" appeal of this area makes it have great potential as a passive park-like space. See **Photo 16.20**.

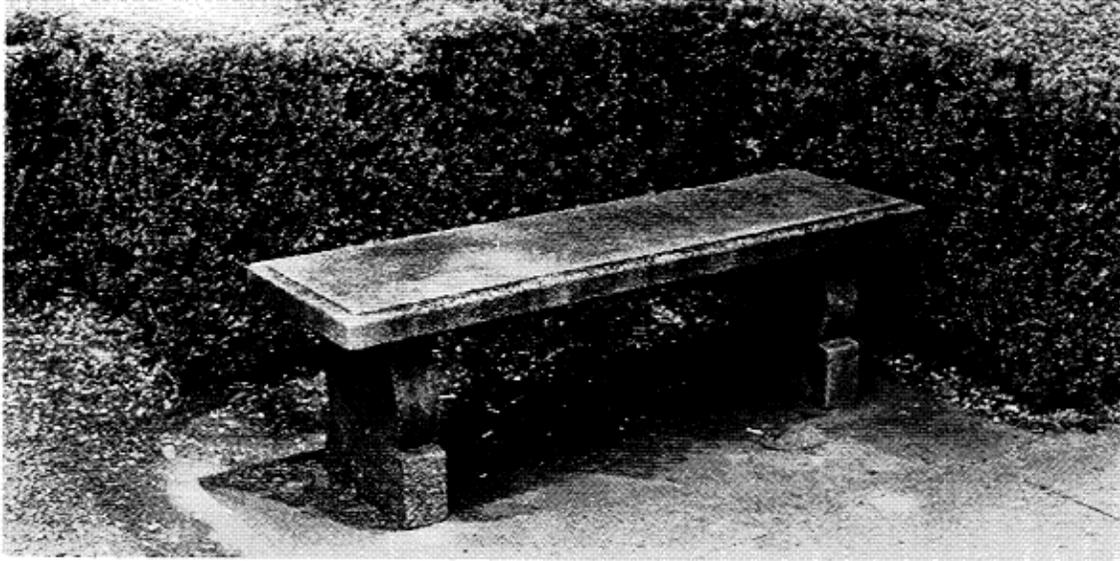
**Photo 16.21**      **Site Furnishings; Original 1936 FSCW Bench**

- b) Benches are located throughout campus. Original detailed benches made of concrete are no longer available, see **Photo 16.21**, and have been superseded in newer areas of campus by concrete benches made by the Physical Plant Dept., which are now the most prevalent type found. See **Photo 16.22**. Numerous other bench types found consist of custom designs for specific locations or conditions; these include Bob Bischoff's "cathedral benches", donated memorial type benches, and miscellaneous ones ordered from site furniture catalogues.

- b) Benches
1. Old Style, FSCW 1936:  
The old style benches on campus are in good condition and these requires little to no maintenance. See **Photo 16.21**.

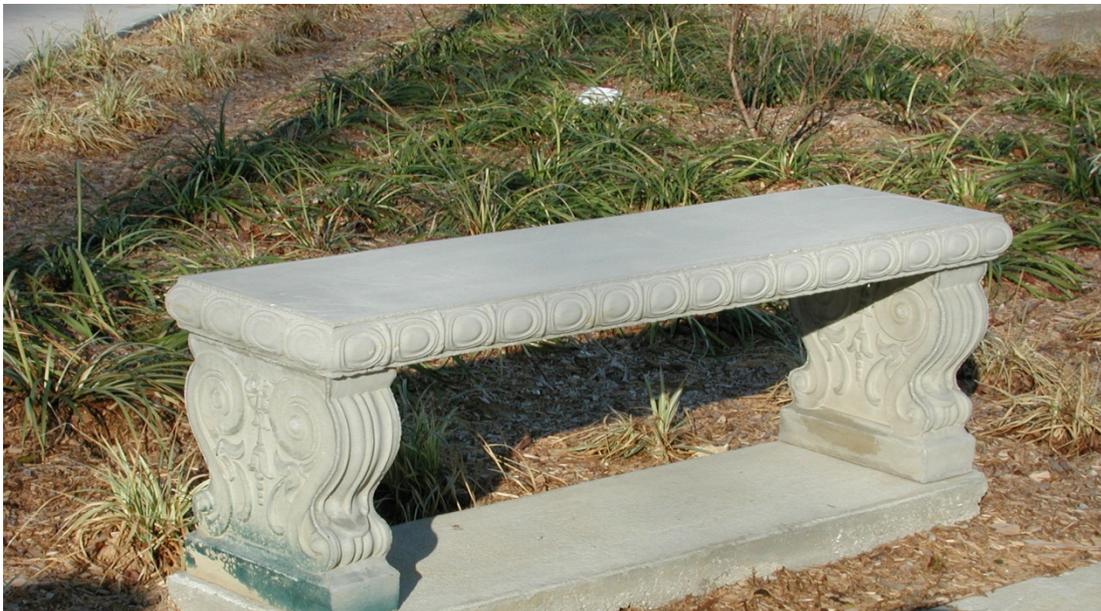
**Photo 16.22**      **Site Furnishings; Replacement Bench**

2. New Style:  
Concrete slab (manufactured by Physical Plant): This type of bench requires little or no maintenance.
  3. Concrete with Wooden Backrest:  
This type of bench requires a higher level of maintenance due to wear, deterioration and vandalism of the wooden backrests. See **Photo 16.22**.

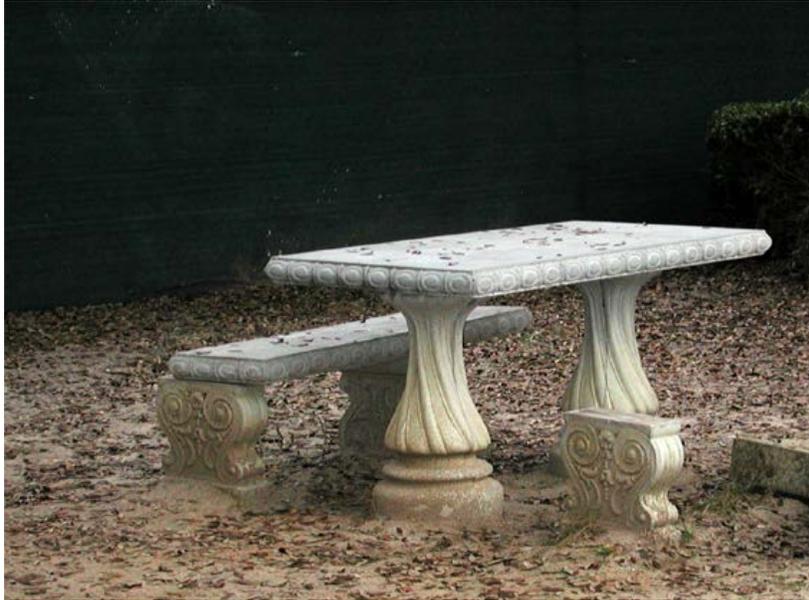
**Photo 16.23**      **Site Furnishings; Tables & Benches**

3. Tables and Benches: Concrete is the material of choice for maintenance reasons. Those of other materials should be phased out and replaced with concrete if their location is used. New purchases have been the “garden shop” variety that is too ornate for an institutional setting. See **Photo 16.23**. A simpler look should be

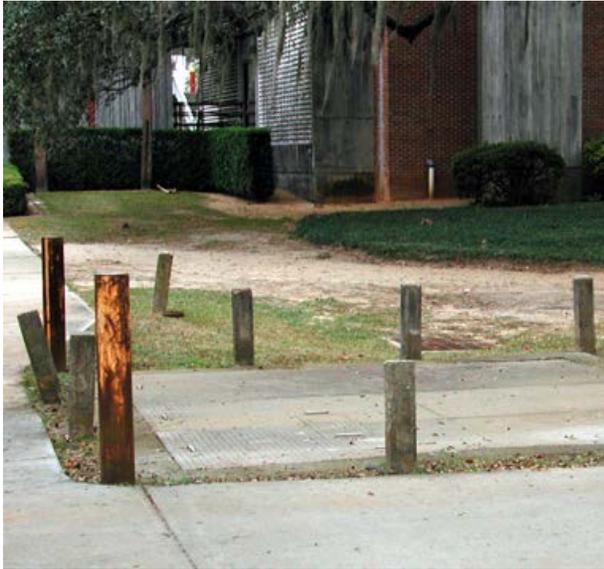
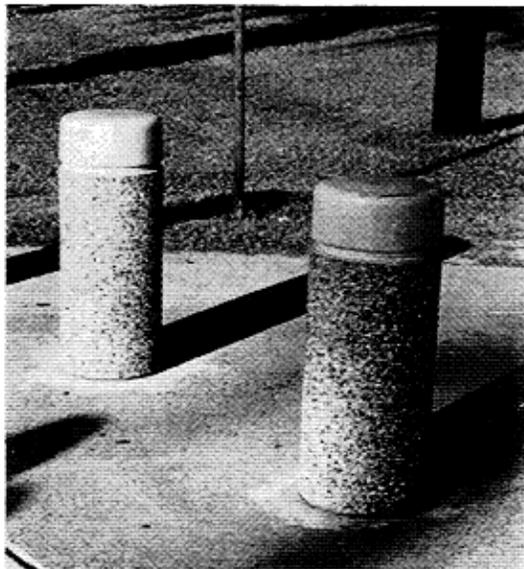
**Photo 16.25**      **Site Furnishings; Bollards**

These bollards are relatively inexpensive initially, but they require a medium amount of maintenance due to wear and vandalism. See **Photo 16.25**.

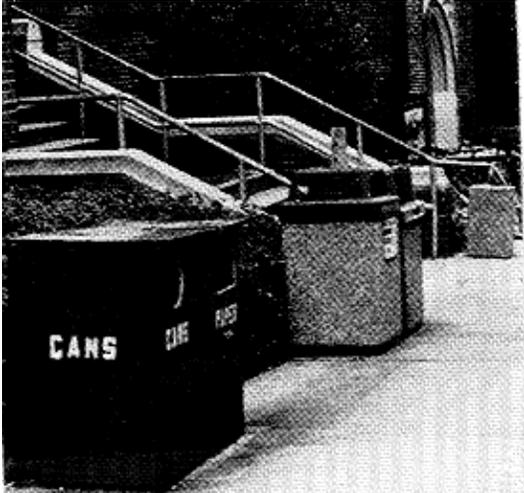
**Photo 16.27**      **Site Furnishings; Trash Receptacles**

- e) Trash receptacles are located throughout the campus. In addition to the dumpster-type described in **1.a.10**, pedestrian-type receptacles are primarily precast concrete with fiberglass tops. They are found in two similar styles. See **Photo 16.27**. Recycling receptacles are also located in small groups on campus and supplement the larger recycling bins found elsewhere on campus. See **Photo 16.28**. If consistency is desired, receptacles should be of same family as benches.

The trash receptacles require little or no maintenance except for the lids that are damaged by wear and tear, and cleaning due to vandalism. There are three different lids in use. One lid is color coded for recycling (blue) and the other two are for trash. See **Photo 16.27** and **16.28**.

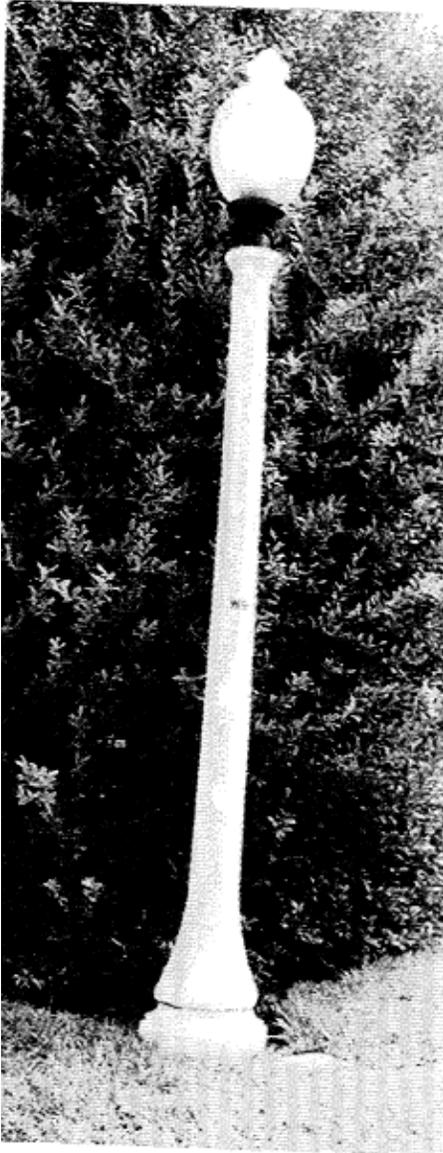
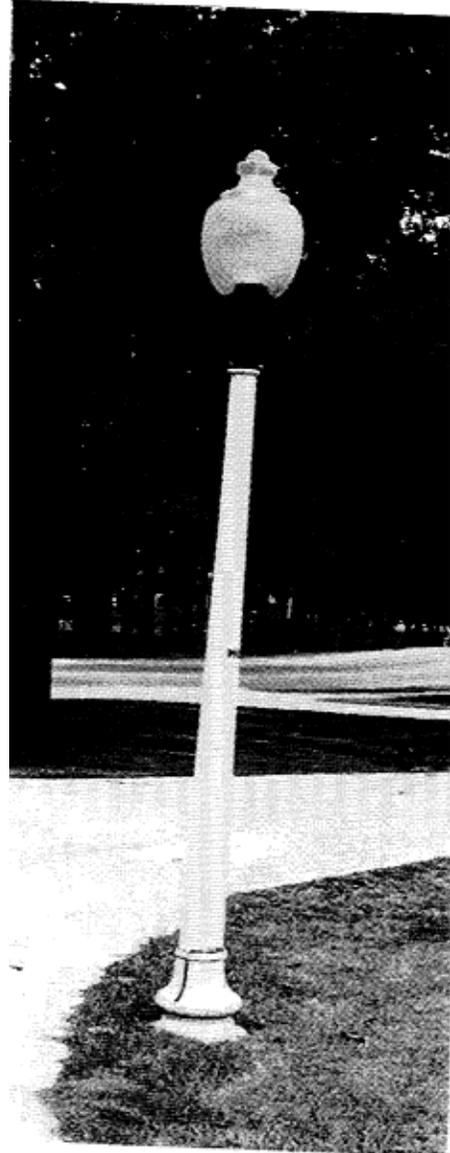
**Photo 16.31a, b**  
**Light Fixtures**

1. The predominant type of fixture is an "acorn"-type lens with either cast aluminum or precast concrete base, as shown in **Photo 16.31a**, which has replaced older precast concrete and cast iron standards which are no longer available. See **Photo 16.31b**. However, reuse or cannibalization of older fixtures sharply reduces their attrition rate and consequently contribute to a variety of fixture types being mixed on campus. In addition to the acorn-type fixtures, more model aluminum standards with differing fixtures are also being installed wherever needed, mixing with the acorn-types. See **Photo 16.31c**. Round and squat aluminum poles of differing heights exist, as do numerous finishes including painted, clear aluminum, and dark anodized aluminum. In some cases, other types of light fixtures were installed with specific building projects and add to the range of fixtures to be found on campus. In addition, there are Blue Light phone fixtures. See **Photo 16.32**. Lamping is either incandescent, high-pressure sodium,

- a) **Old Style Acorn** (Cast Iron Base)  
These lights require low maintenance that involves lamp changing and some painting or cleaning due to damage by vandals.

- b) **New Style Acorn** (Cast Concrete Base)  
These types of lights require low maintenance that involves lamp changing and some painting or cleaning due to damage by vandals.

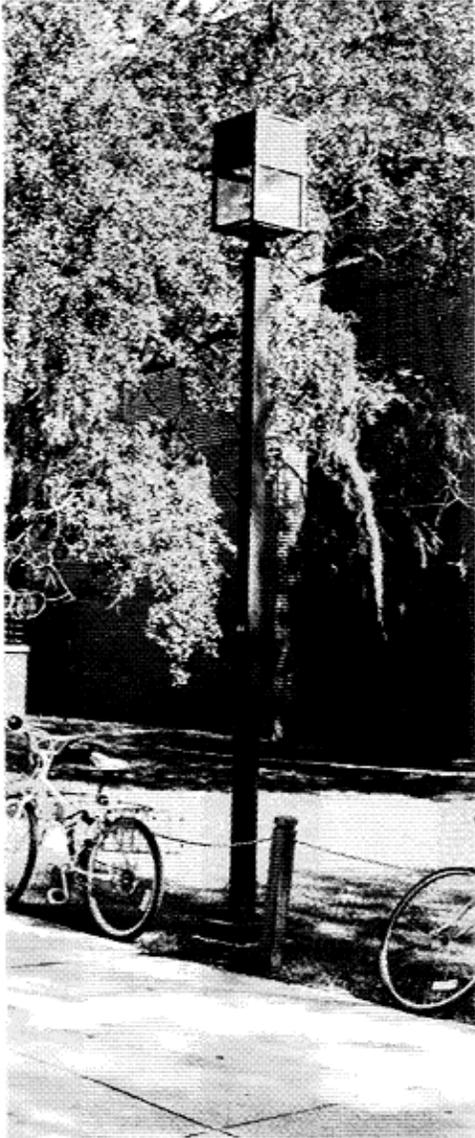
**Photo 16.31**      **Light Fixtures**

C.      Metal Fixture  
         And Pole

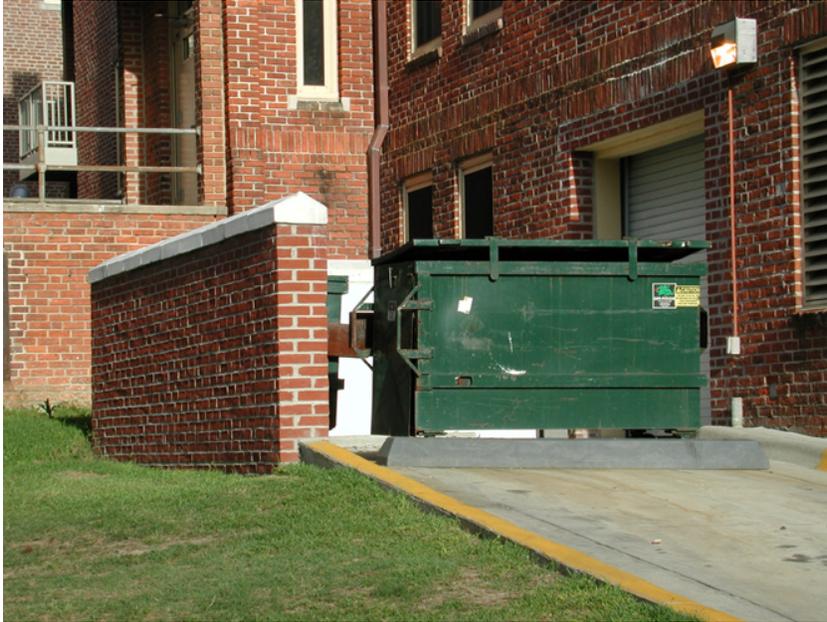
**Photo 16.33 Trash Collection**

**1a.10 Trash Collection Facility:** Trash Collection Facilities occur throughout the campus See **Figure 16.7**. A significant majority are highly visible to the public with dumpsters, and in most cases, immediately adjacent to walkways. On-site observation noted that where walled enclosures were present, which were few, dumpsters were outside the enclosure in plain view. It is our understanding that trash collection personnel do not leave the truck to access enclosures, nor do they put the dumpster into enclosures after emptying the dumpster. See **Photo 16.33**.

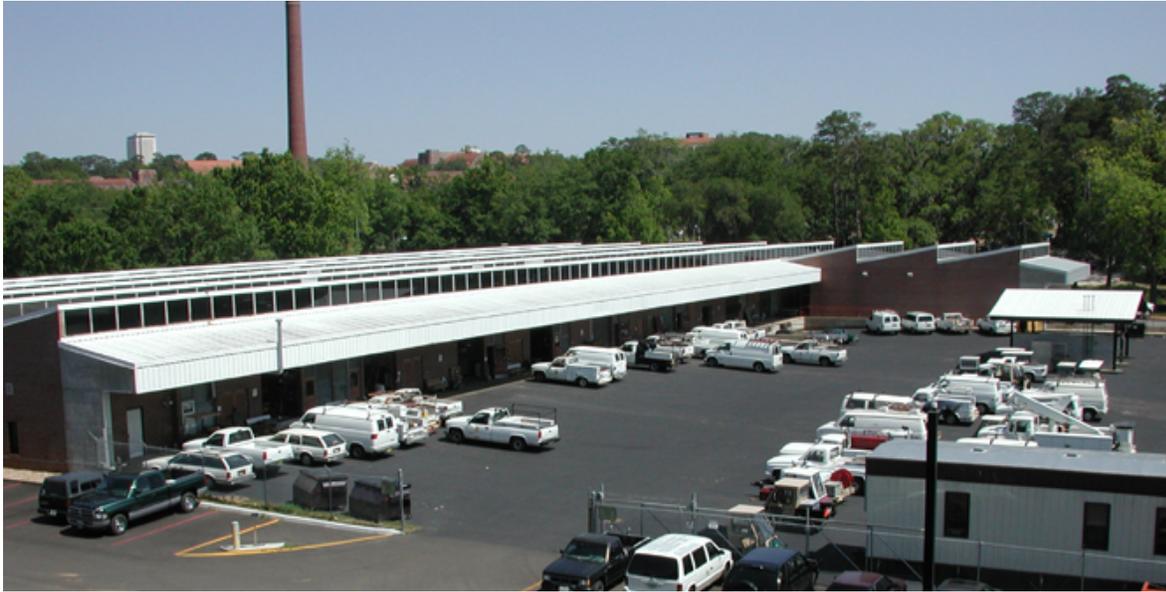
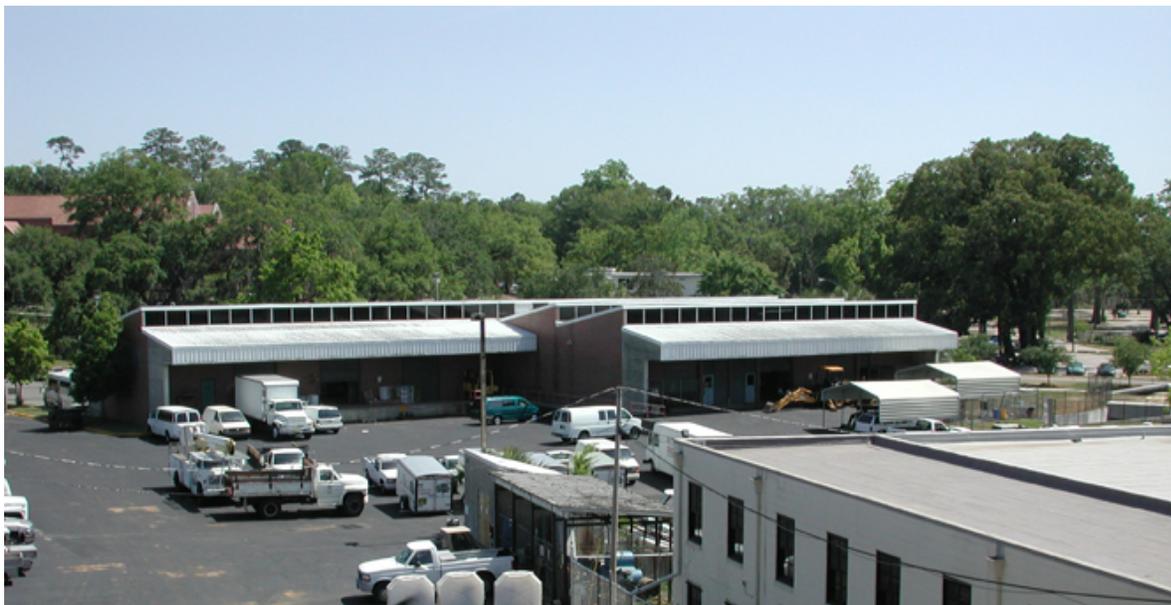
**Photo 16.35 Maintenance Facility**

**1.a.11 Maintenance Facility:** FSU's Maintenance Facility is in the geographical center of the main campus. See **Figure 16.7**. It commands sizeable acreage and has a large and highly visible service yard that contains not only vehicles, but also the storage and stockpiling of materials as well. Unfortunately, for security reasons, a high chain link fence surrounds the yard with barbed wire creating a visual anomaly in an "open" campus. See **Photo 16.35 and 16.36**.

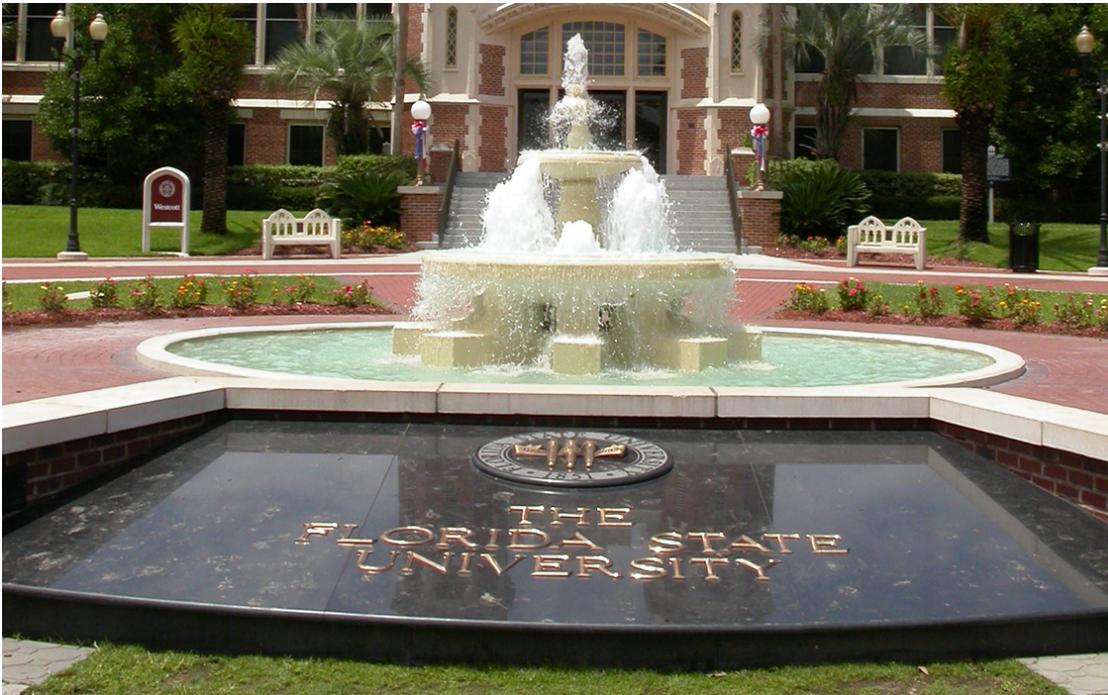
**Photo 16.44**    **Fountains**

- 1.d.3 Fountains:** Fountains are found in three locations of campus. They are simple, pedestrian in scale, and add charm to their locations. However, they require high maintenance costs. See **Figure 16.9** and **Photo 16.44**.
