Landscape Architectural Design Guidelines Supporting Data**1. Inventory and Analysis of Existing Conditions**

1.a. An inventory of the existing character, quality, and location of landscape treatments on the Tallahassee Campus are as follows:**1.a.1. Vehicular Circulation Routes:** Vehicular circulation routes on and around campus include:

16 Landscape Architectural Design Guidelines**Landscape Design Guidelines- Addition 2001****RE:** Advanced Inventory and Analysis of Existing Conditions**The Institutional Landscape of Florida State University:**

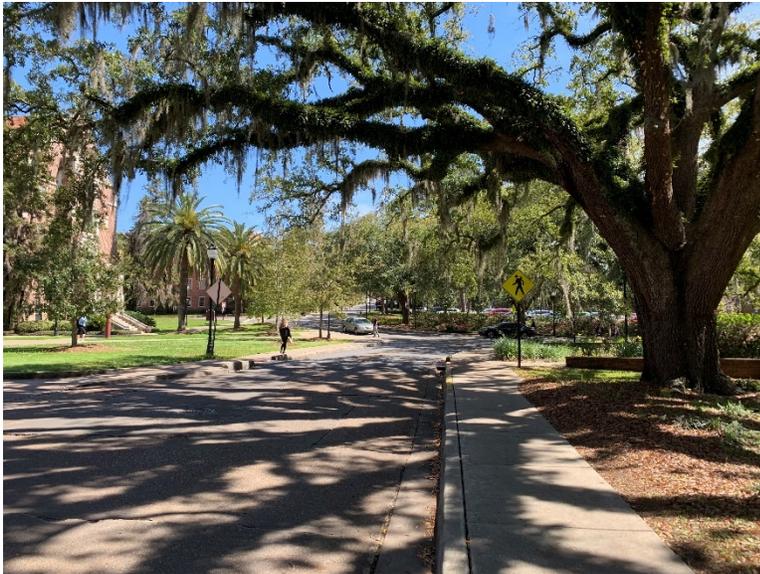
Photo 16.1 Local Vehicular Routes – University Way

- a. **Local two-lane roads** - These roads are asphalt surfaced. A comfortable scale is presented with building proximity and massing. There are large older trees nearby. The road edge treatment and landscape consist of curb, asphalt, sidewalks, and mature trees. See **Photo 16.1**.

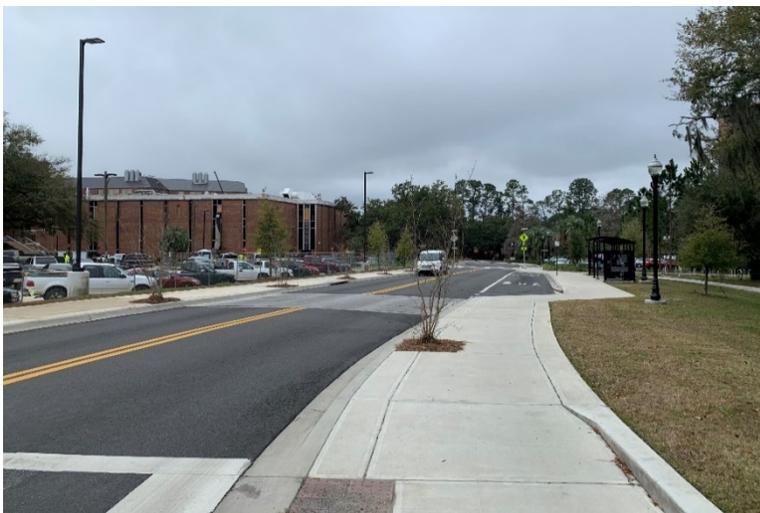
Photo 16.2 Minor and Major Collector Vehicular Route - Chieftan Way

- b. **Minor and Major two-lane Collector roads** - These asphalt surfaced roads connect all zones and districts. There are recently planted trees along these routes. These routes are used by the campus bus system. The edge treatment and landscape consist of curb, asphalt, sidewalks, and young trees. See **Photo 16.2**.

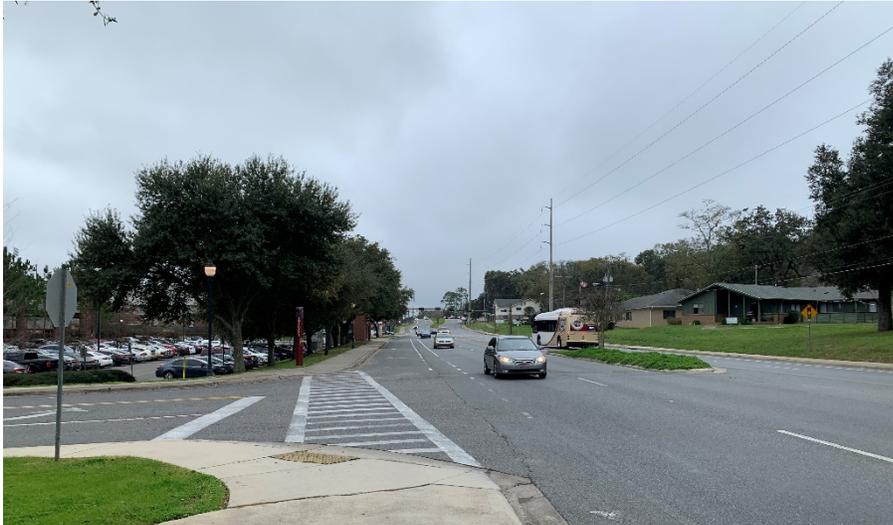
Photo 16.3 Minor and Principal Arterial vehicular route – Stadium Dr.

- c. **Principal Arterial and Minor routes that surround the campus** – These asphalt surfaced roads are more than two lanes in width and connect the entire campus with its immediate surroundings. Landscape along these routes is minimal. Edge treatment and landscape consist of curb, sidewalks, asphalt and generally these routes have a median in the middle. See **Photo 16.3**.

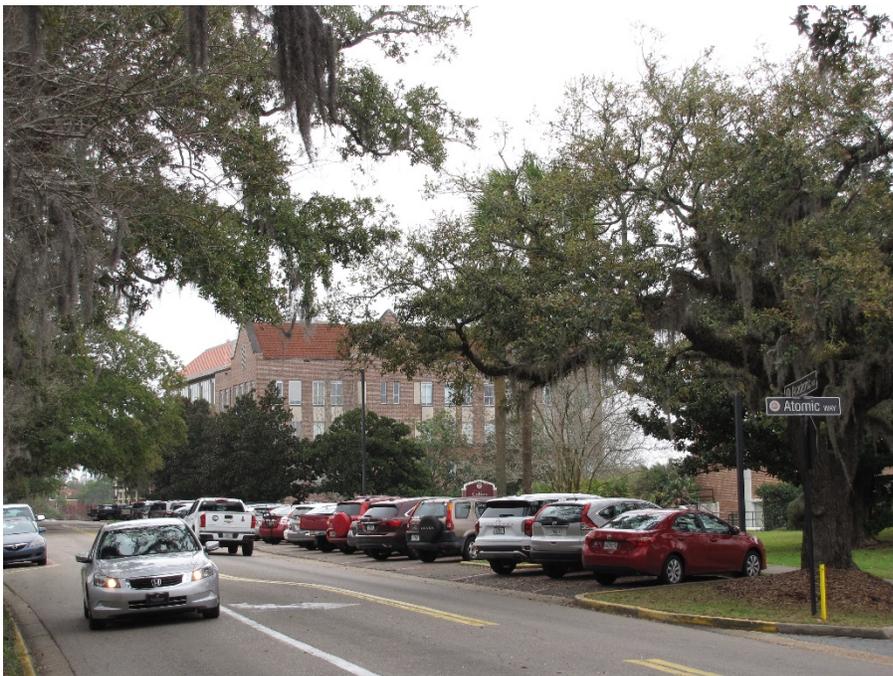
Photo 16.4 Vehicular route with on-street parking - Academic Way

- d. **Roads with On-Street Parking** – The edge treatment and landscaping consist of curb, asphalt, parking, sidewalks and some trees. See **Photo 16.4**.

1. Bicycle Facilities: Bicycle facilities are distributed across campus. and apparently are heavily used. There are five different types of bike racks on campus with only one being fully utilized by students; the high pipe hoop. However, the high hoop is not located everywhere and if given a choice by students, all other racks would be ignored. Therefore, all other racks should be removed and replaced by high hoops to eliminate the visual clutter created by the unattractive, unused racks. See **Photo 16.4**.

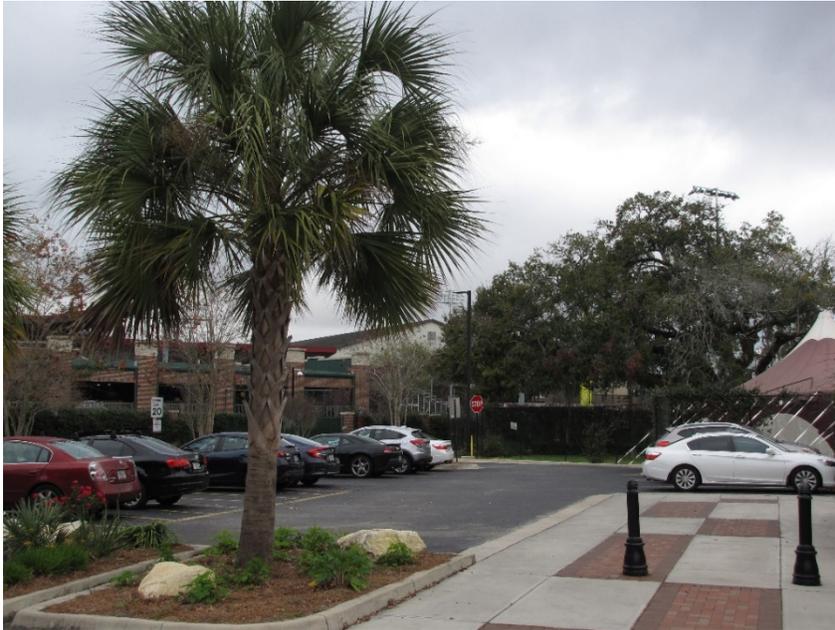
Photo 16.5 Small Asphalt Parking Lot – Circus Tent

- a. Asphalted lots, smaller in size and not too visually imposing. See **Photo 16.5**.
- b. Asphalted lots that, depending on their organization, orientation and visibility, vary in their visual impact. See **Photo 16.6**.
- c. Asphalted lots, large in size and located adjacent to a campus street. These tend to have a strong visual impact. See **Photo 16.7**.
- d. Graveled lots, very few and located at the campus periphery. See **Photo 16.8**.

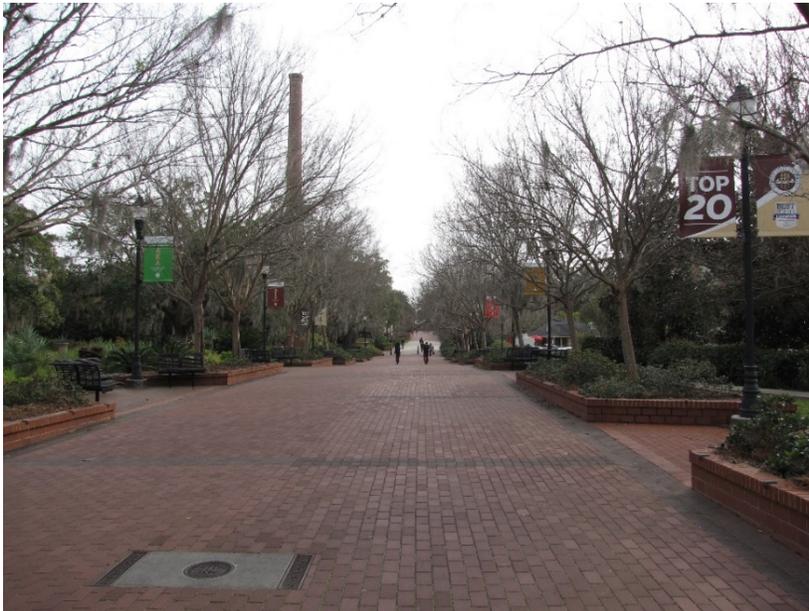
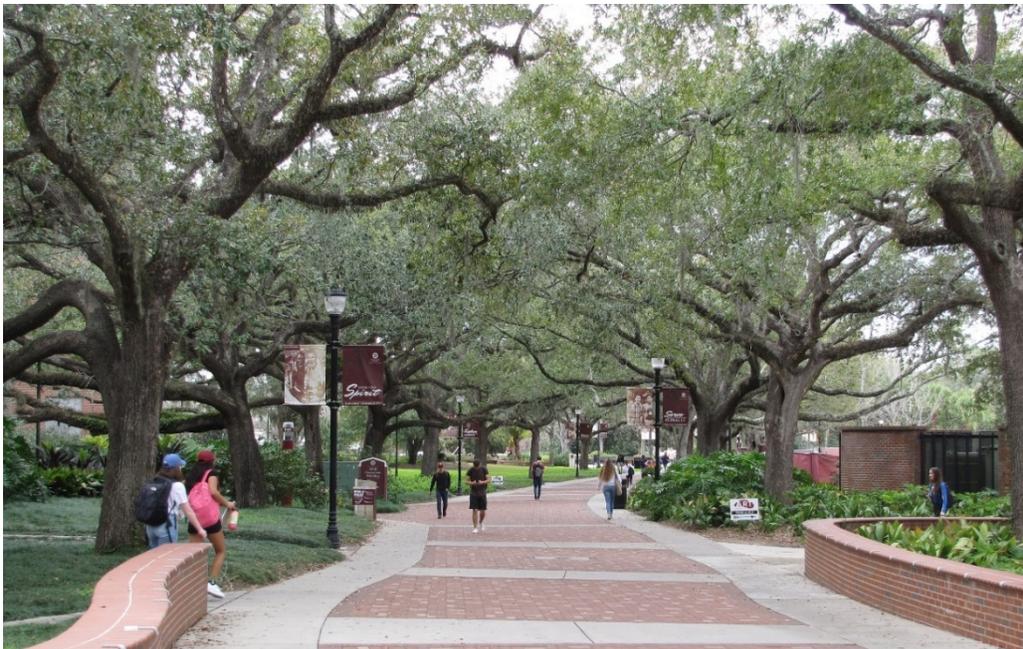
There are two major pedestrian circulation routes that run North-South, Woodward Mall and East-West, Call Street corridor. See **Photos 16.9 and 16.10**. There is an appropriate relationship between the distribution from these two main pedestrian paths to the remainder of the connecting of pedestrian walks. There are also adequate connector paths to open spaces that occurs between buildings. See **Photos 16.11 and 16.12**.

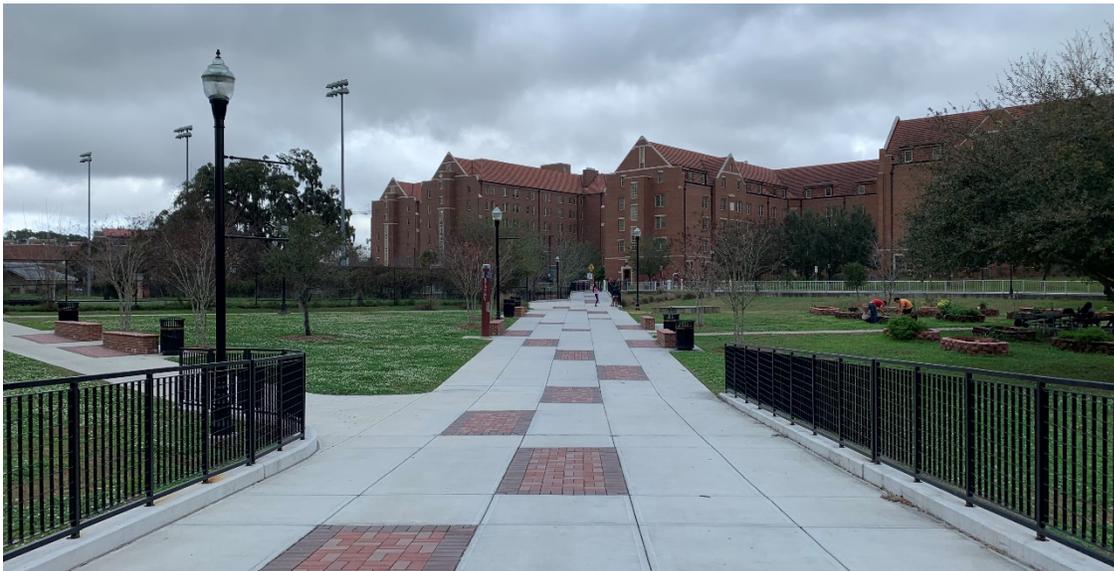
Photo 16.12 Pedestrian Circulation – Path between Wildwood Hall and University Center

Pedestrian tunnels and bridges occur in several locations on campus. Tunnels occur at two perimeter “crossings” of Tennessee and Pensacola Streets where wide roads and heavy traffic would conflict with pedestrian desire lines to get from one side to the other. There are also a few bridges that span the swales from past drainage ditches. See **Photos 16.12**.

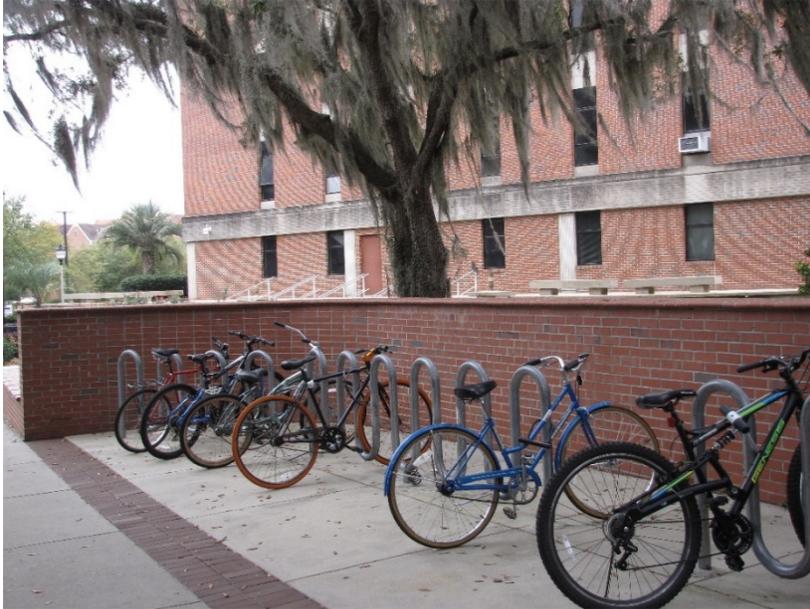
Photo 16.13 Bicycle Parking Facility typical around buildings

- 1.a.4. Bicycle Facilities:** Bicycle parking facilities are distributed throughout campus. All are adjacent to pedestrian circulation systems and are on paved surfaces. See **Photo 16.13** and **16.14**.

- a) Bicycle Parking Facilities are located throughout campus. There are also bicycle service stations. The effort to curtail bicycles being chained to fences, trees, railings and signposts is ongoing. See **Photos 16.13 and 16.14**

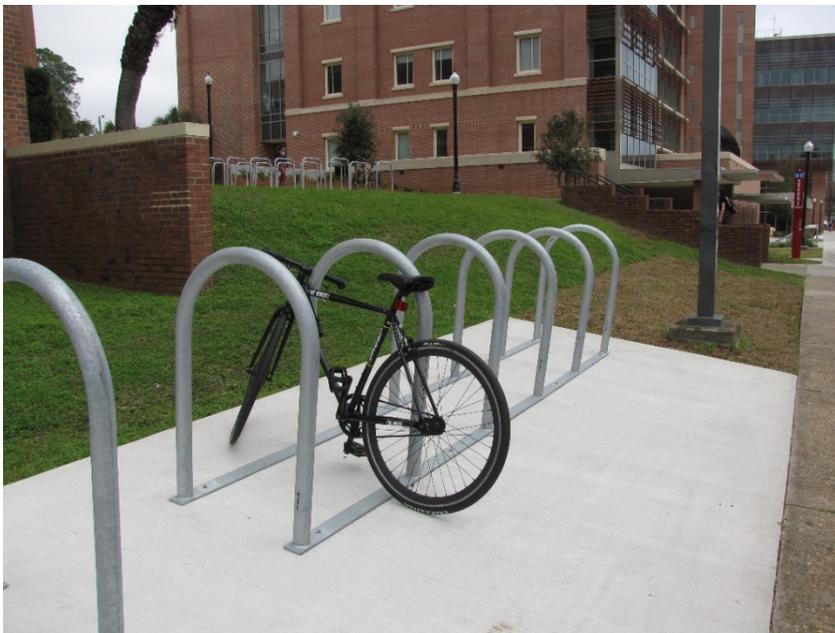
Photo 16.14 Bicycle Parking Facility typical around buildings

- The precast concrete bike racks require little or no maintenance. See Photo 16.14.
5. Triangular Steel Frame:
The triangular steel racks require a little more maintenance than the concrete racks due to rusting. See Photo 16.14.

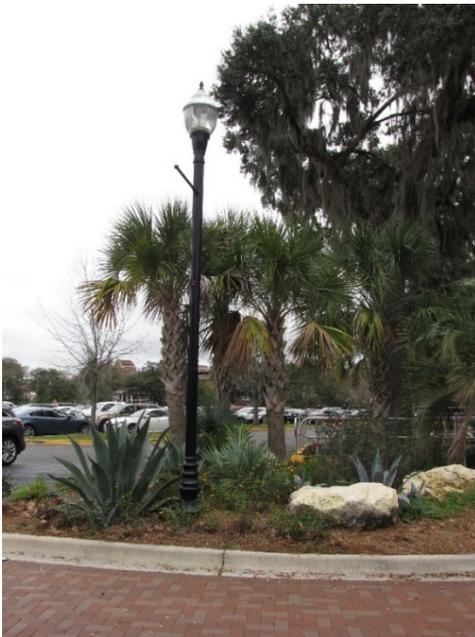
Photo 16.18 Existing Planting Areas, younger vegetation – South of Circus Tent

- 1a.7. Planted Areas:** Nearly all of the Tallahassee Campus grounds are improved and maintained landscape comprised predominantly of lawns and tree with the dominant tree species being Live Oaks and Slash Pines. In the older parts of campus, east of Woodward Avenue, a substantial amount of shrub materials exist as foundation and accent planting. See **Photo 16.17**. Newer parts of campus have new plant masses, improving spaces of layering and scale. See **Photo 16.18**.

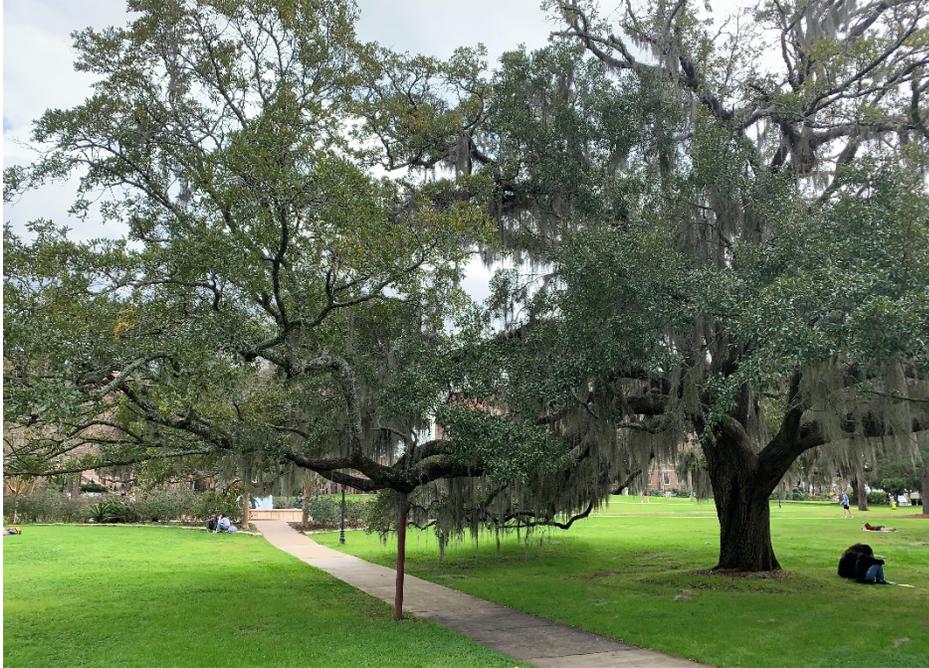
Photo 16.19 Existing Planted Areas, historic landscaping – Landis green – east side of campus

Historical accounts indicate that early campus development included saving existing Live Oaks and Pines and providing lawn in disturbed areas. It was not until the early 1930's that landscaping took place for enhancement purposes. At that time, additional trees and shrubs were added, a significant number of which survive today and make campus a special place for students. See **Photo 16.19**.

The Landscape Visual Quality Analysis, is largely derived by the positive or negative influence the landscape has on the viewer. The richer more varied spaces have a high visual quality, see **Photo 16.19**, and are more appreciated spaces on campus than relatively barren landscape as found in the northwest corner of campus. See **Photo 16.18**. Campus landscape enhancement should focus on upgrading the northwest area giving it scale, texture and layering.

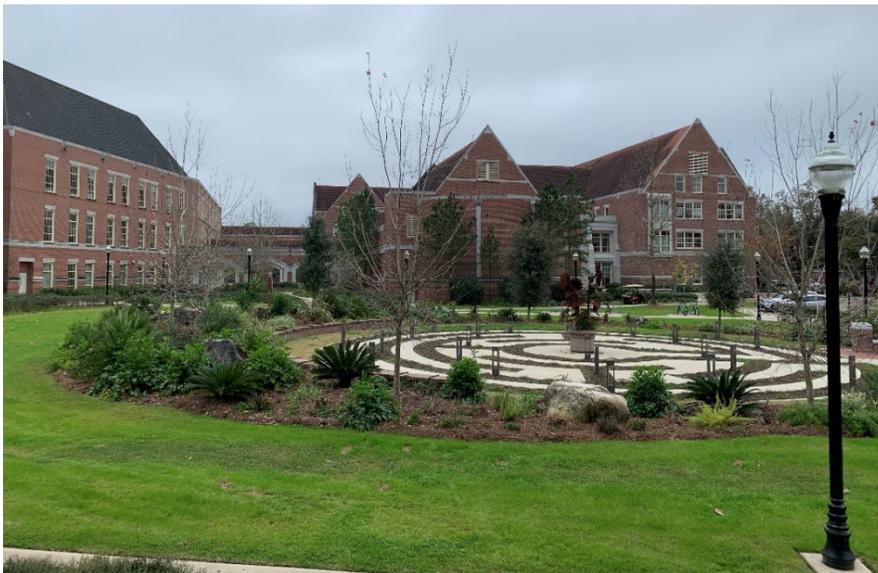
Photo 16.20 Existing Planted Areas, recent landscaping – labyrinth – west side of campus

As the campus developed to the west, crossing Woodward Avenue, large trees were saved wherever possible to maintain the continuity of campus landscape dominated by large trees. New supplemental canopy trees exist and a higher percentage of installed palms can be found, particularly in the science and residence hall areas in the northwest. A recent landscape effort was the construction of a labyrinth between the Psychology and Medical School. It is an attractive and highly appreciated campus spaces. See **Photo 16.20**

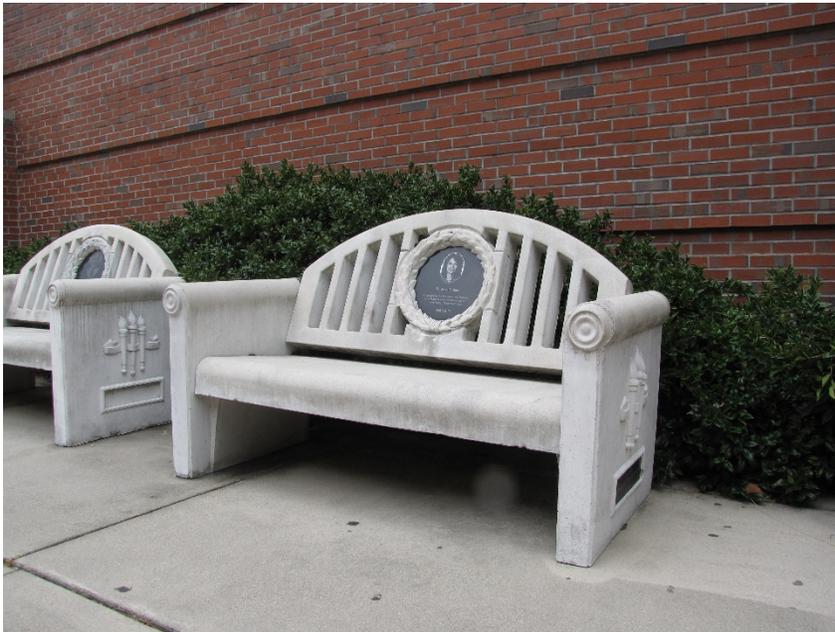
Photo 16.21 Site Furnishings – bench

- b) Benches are located throughout campus. There are a few types of benches, the most prevalent being concrete benches, see **Photo 16.21**, and metal benches, see **Photo 16.22**. Numerous other bench types found consist of custom designs for specific locations or conditions; donated memorial type benches, and miscellaneous ones ordered from site furniture catalogues.

- b) Benches
1. Old Style, FSCW 1936:
The old style benches on campus are in good condition and these requires little to no maintenance. See Photo 16.21.

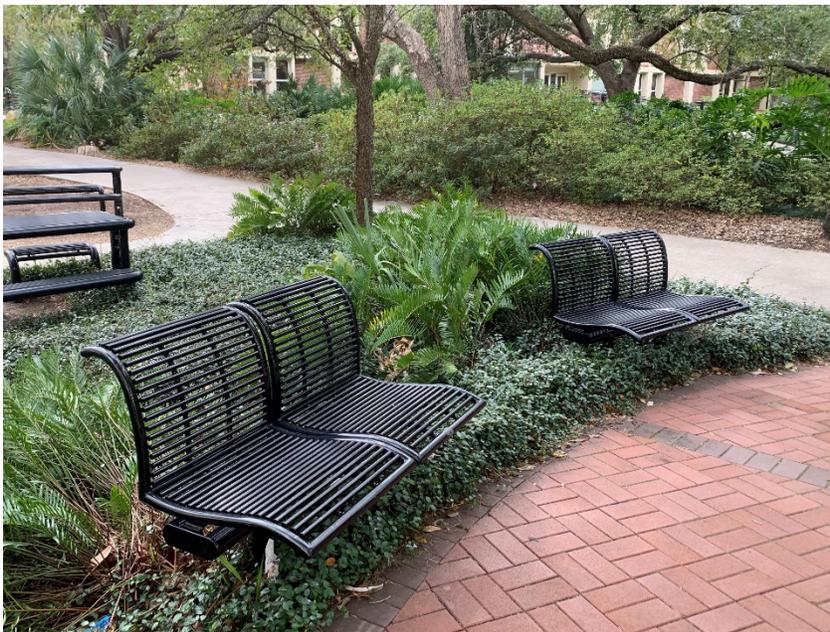
Photo 16.22 Site Furnishings – metal bench

2. New Style:
Concrete slab (manufactured by Physical Plant): This type of bench requires little or no maintenance.
3. Concrete with Wooden Backrest:
This type of bench requires a higher level of maintenance due to wear, deterioration and vandalism of the wooden backrests. See Photo 16.22.

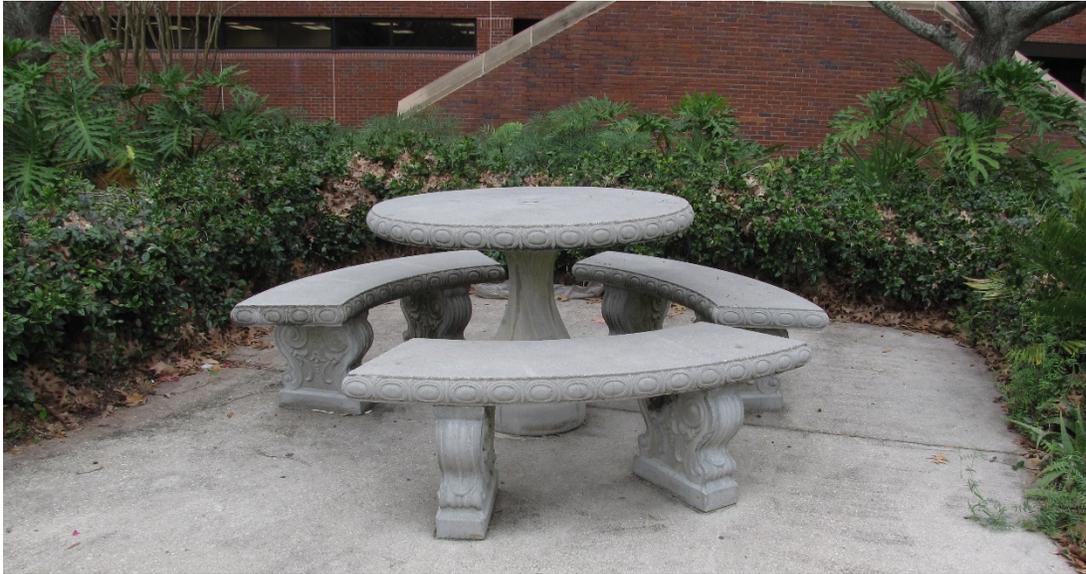
Photo 16.23 Site Furnishings - Tables & Benches

3. Tables and Benches: Concrete is the material of choice for maintenance reasons. Those of other materials should be phased out and replaced with concrete if their location is used. New purchases have been the “garden shop” variety that is too ornate for an institutional setting. See **Photo 16.23**. A simpler look should be chosen.

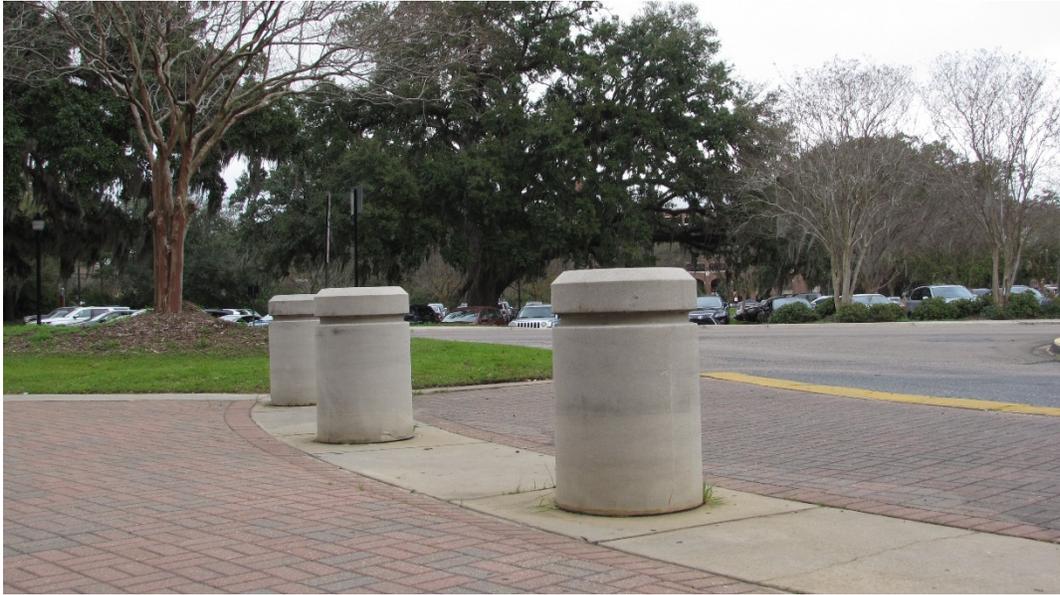
Photo 16.25 Site Furnishings - Bollards

1. Wooden w/chains:
These bollards are relatively inexpensive initially, but they require a medium amount of maintenance due to wear and vandalism. See Photo 16.25.

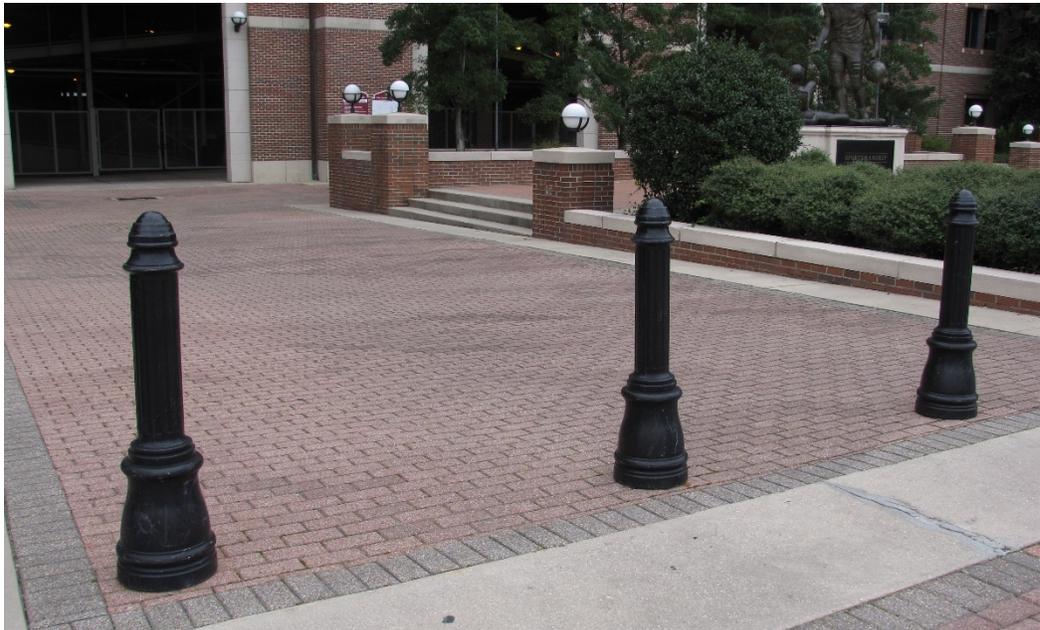
Photo 16.26 Site Furnishings – Bollards

This type of bollard requires low maintenance but are not large enough to prevent some vandalism. See Photo 16.26.

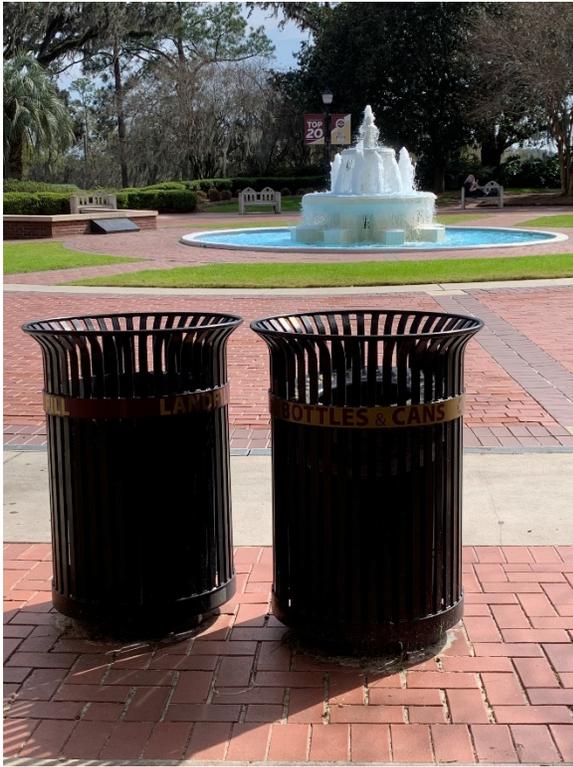
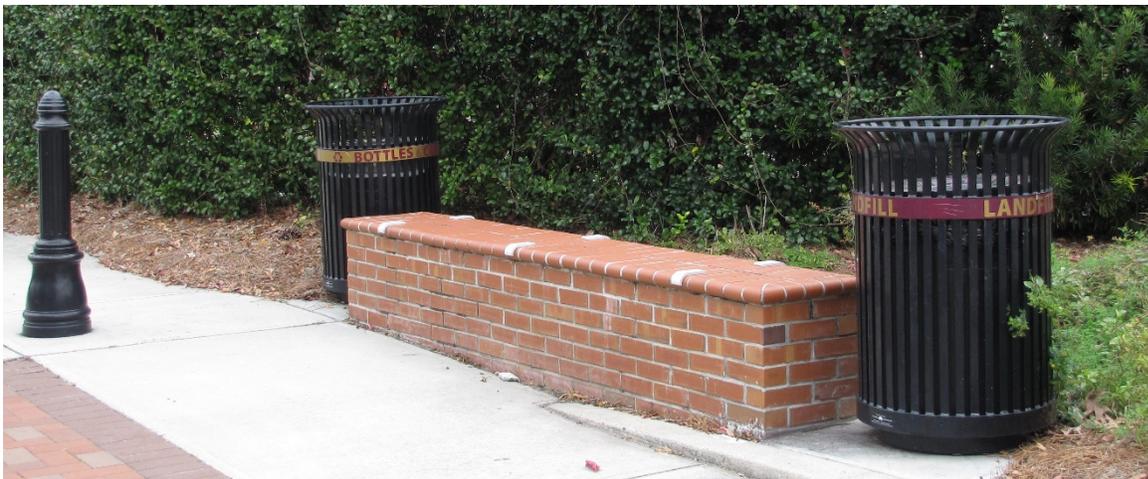
The trash receptacles require little or no maintenance except for the lids that are damaged by wear and tear, and cleaning due to vandalism. There are three different lids in use. One lid is color coded for recycling (blue) and the other two are for trash. See Photo 16.27 and 16.28.

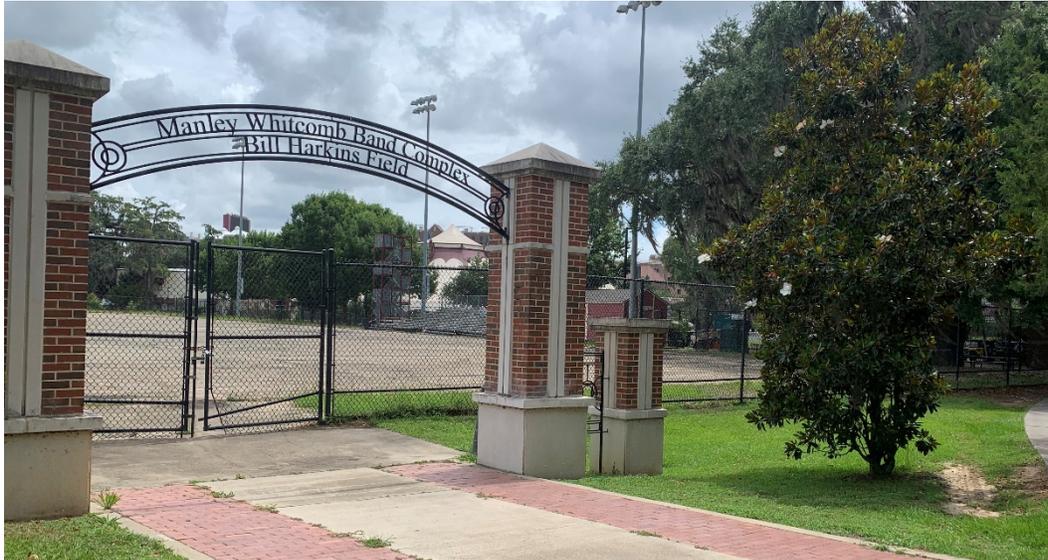
Photo 16.29 Fences

Galvanized fencing generally is maintenance free. However, when rails and posts are bent or damaged, the whole fencing section looks bad. The fencing along the drainage channel, mid-campus, has had some vandalism. See Photo 16.29.

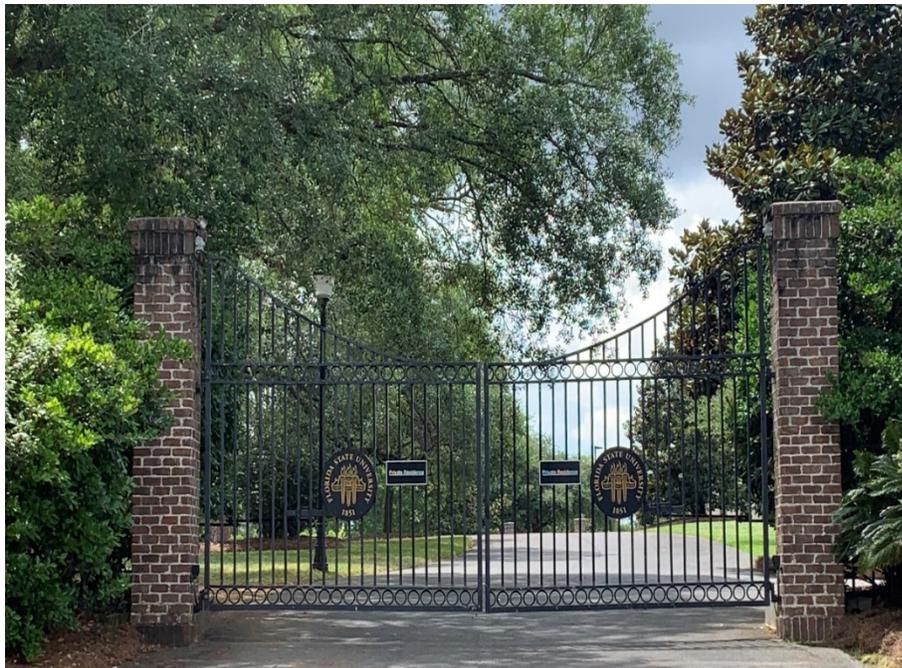
Photo 16.30 Ornamental fences

There is painted steel and wrought iron fencing and gates which needs little maintenance except for corrosion checks and painting. See Photo 16.30.

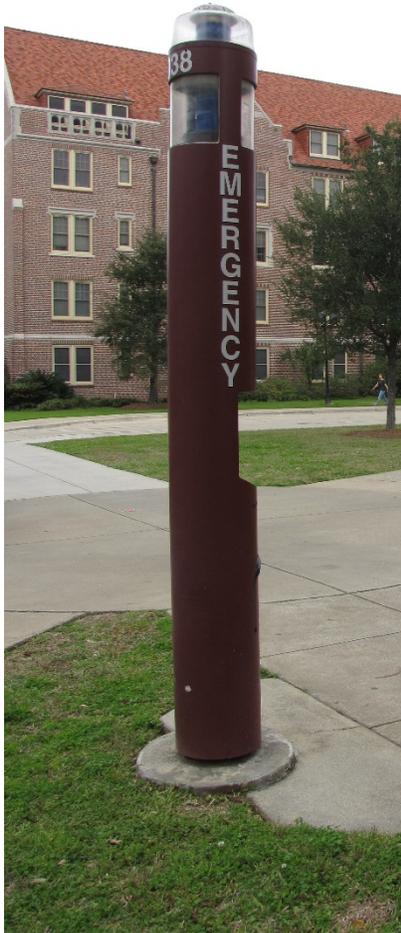
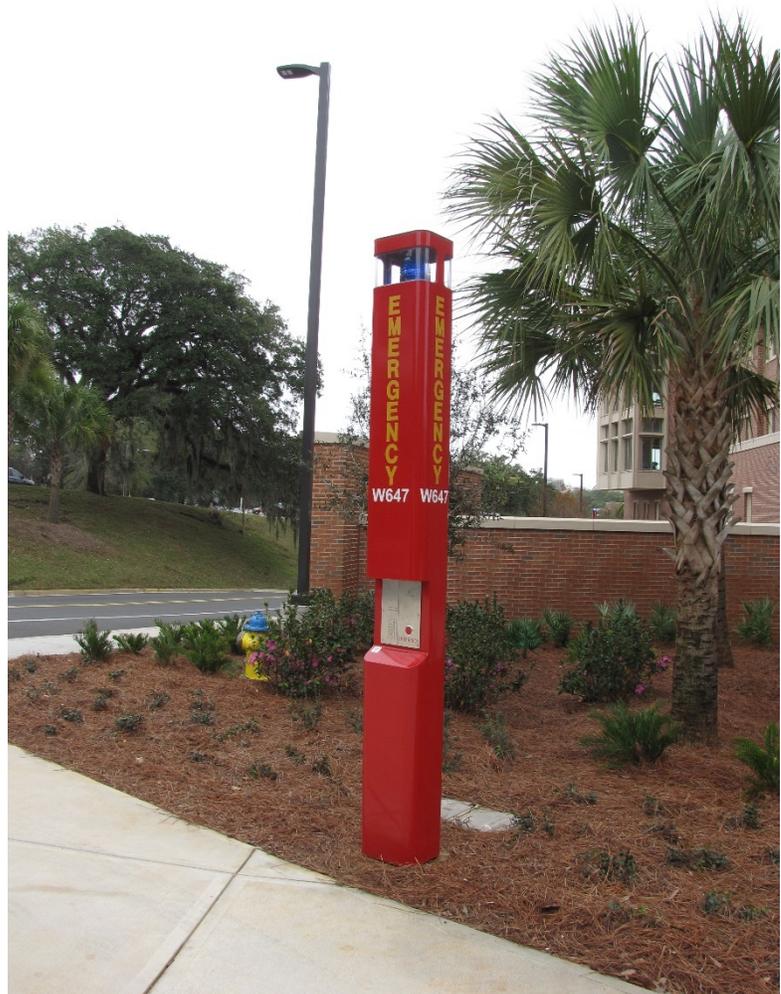
Photo 16.31 Blue Light Phone Fixture

other types of light fixtures were installed with specific building projects and add to the range of fixtures to be found on campus. In addition, there are Blue Light phone fixtures. **See Photo 16.31.** Lamping is either incandescent, high-pressure sodium, or metal halide, are therefore produce differing light colors. New aluminum fixtures have a more efficient light distribution than the acorn type.

7. “Blue Light” Emergency Phone Fixtures: Presently the Blue Light fixtures consist of a standard aluminum light pole with a weatherproof phone box attached, and a blue light on top. These are soon to be replaced with a newer style integrated unit, designed for this purpose. All supplemental units to the system will be of this type, which is easier to use and more visible at night, while still being an attractive unit.

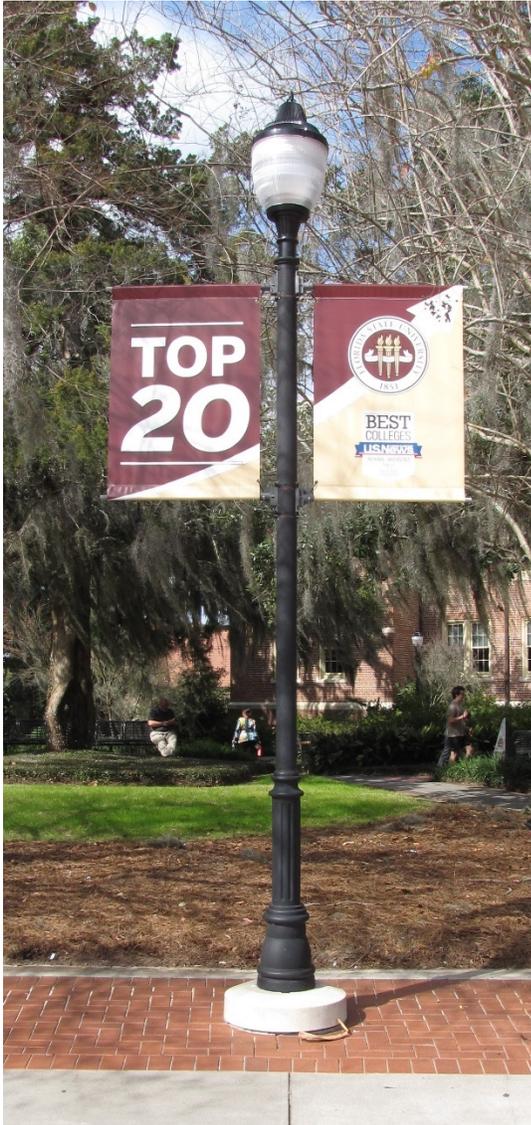
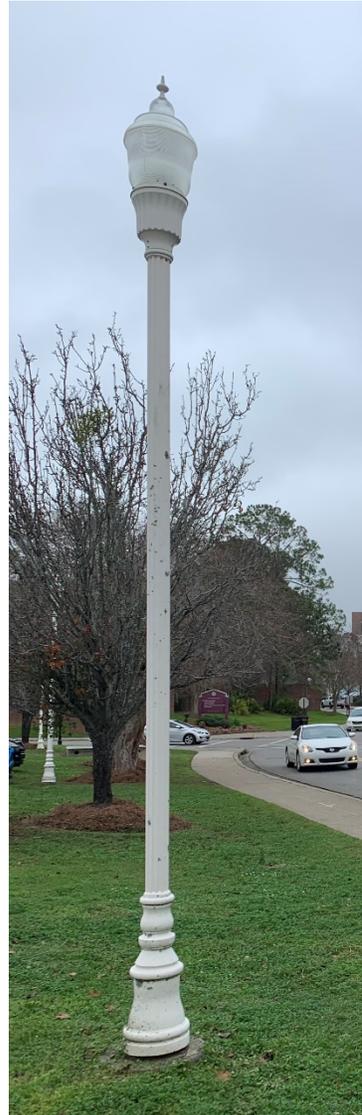
Photo 16.32 Light Fixtures

1. The predominant type of fixture is an “acorn”-type lens with either cast aluminum or precast concrete base, as shown in **Photo 16.32a**, which has replaced older precast concrete and cast iron standards which are no longer available. See **Photo 16.32b**. However, reuse or cannibalization of older fixtures sharply reduces their attrition rate and consequently contribute to a variety of fixture types being mixed on campus. In addition to the acorn-type fixtures, more model aluminum standards with differing fixtures are also being installed wherever needed, mixing with the acorn-types. See **Photo 16.33**. Round and squat aluminum poles of differing heights exist, as do numerous finishes including painted, clear aluminum, and dark anodized aluminum. In some cases,

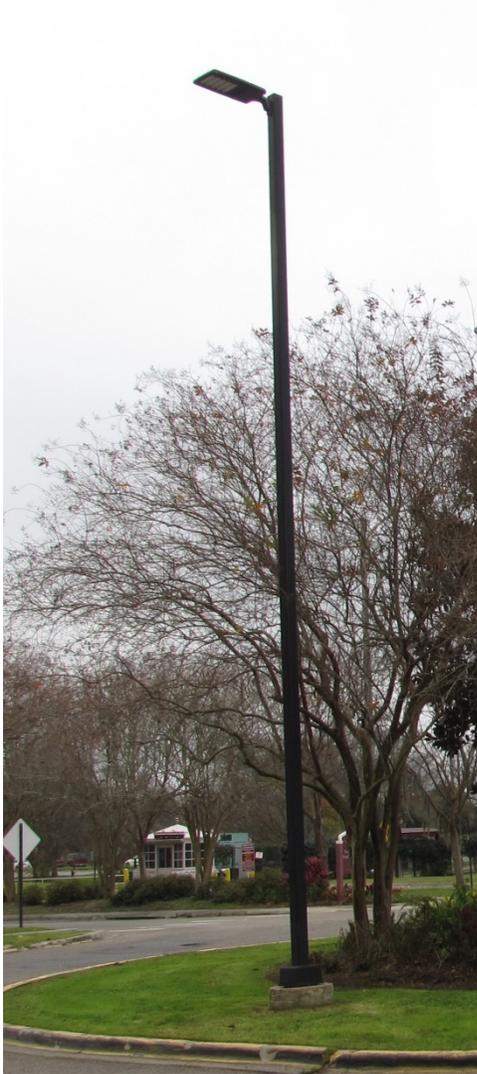
Photo 16.33 Light Fixtures

A. Replacement Light Fixture

B. Original Light Fixture

Metal Light Fixture Pole

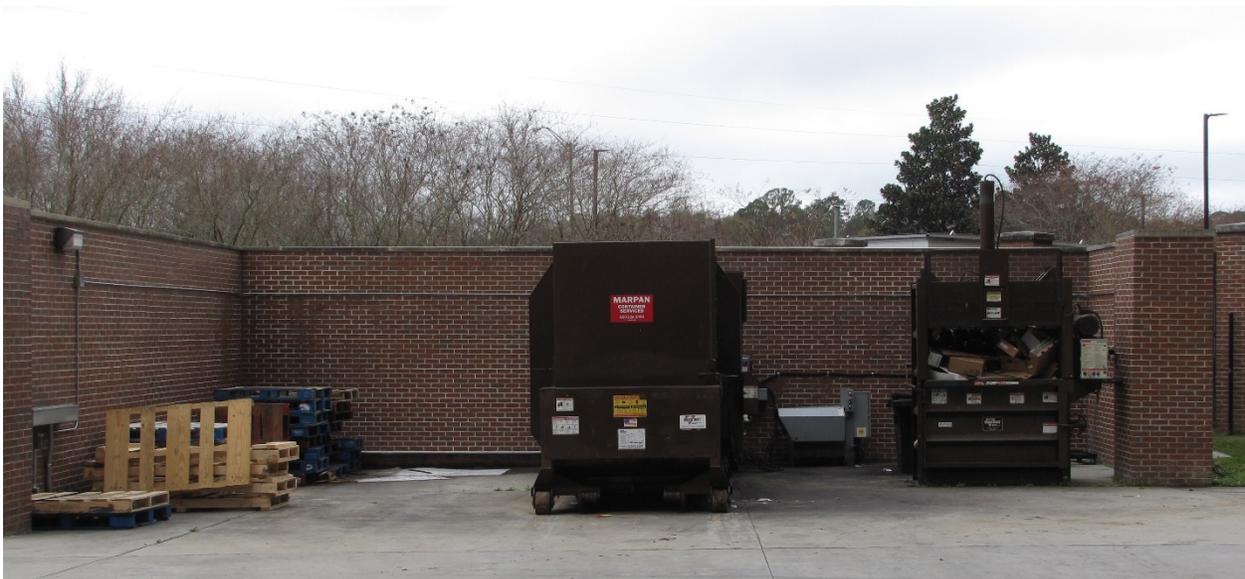
Photo 16.35 Trash Collection, Recycle Facility

Large recycling dumpsters occur in two locations on campus. They too are in locations where they are partially visible. **See Photo 16.35.**

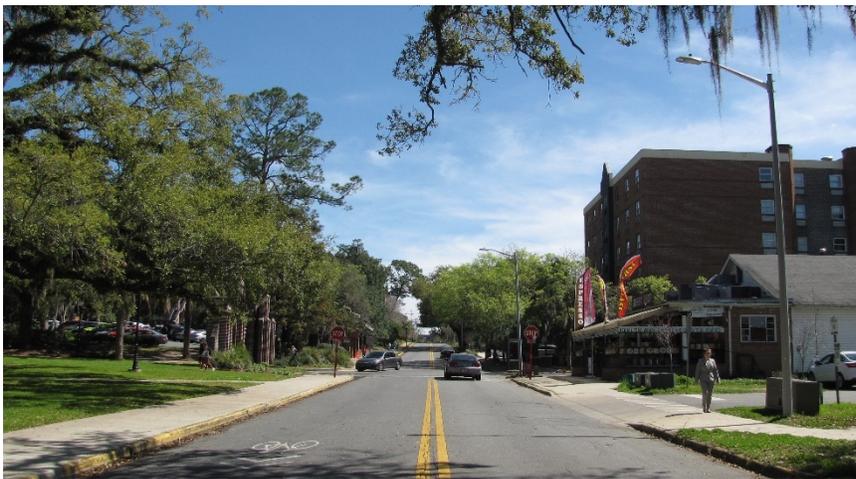
Photo 16.41 Campus Edges; Jefferson Street

Adjacent land uses and quality of structure varies as well. Most land use consists of residential-type buildings ranging from apartments, "Greek" housing, single-family residential (housing students), etc. Other uses include commercial and retail structures and a few civic structures. In general, the quality of the immediate neighboring structures is not very high. **See Photo 16.41.** Parking lots can also be found on the campus perimeter in some areas.

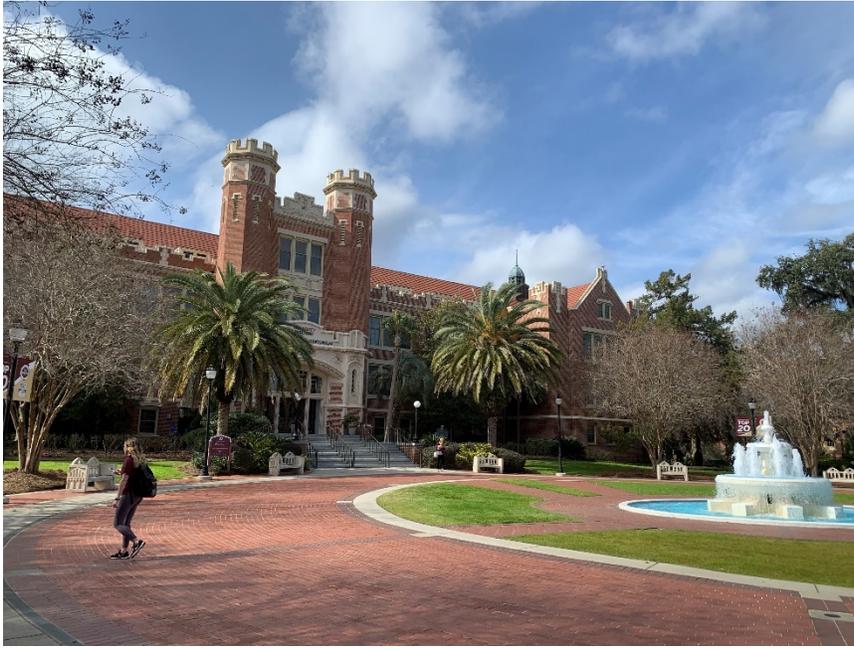
Photo 16.42 Historic Landscape; Westcott Frontage

An important element of the campus look is the character of the Old Campus architecture framed by Canary Date Palm trees, See **Photo 16.42**, shaded by the Live Oak hung with Spanish moss and the groves of tall Slash Pines. The Westcott Building and Entrance is the primary historic element of the campus and will remain sacrosanct in the minds of alumni because it stands as the icon of their time spent here. Improvements made to the Westcott courtyard are in context with the historic space. Landis Green too is as important a space to the campus as the Westcott Entrance because it is the main-focus and gathering point on campus and its psychological center. The master plan calls for removal of trees from the historic green to strengthen the visual connection between Landis Hall and Strozier Library and supplementing additional Live Oaks along its edges. See **Photo 16.43**.

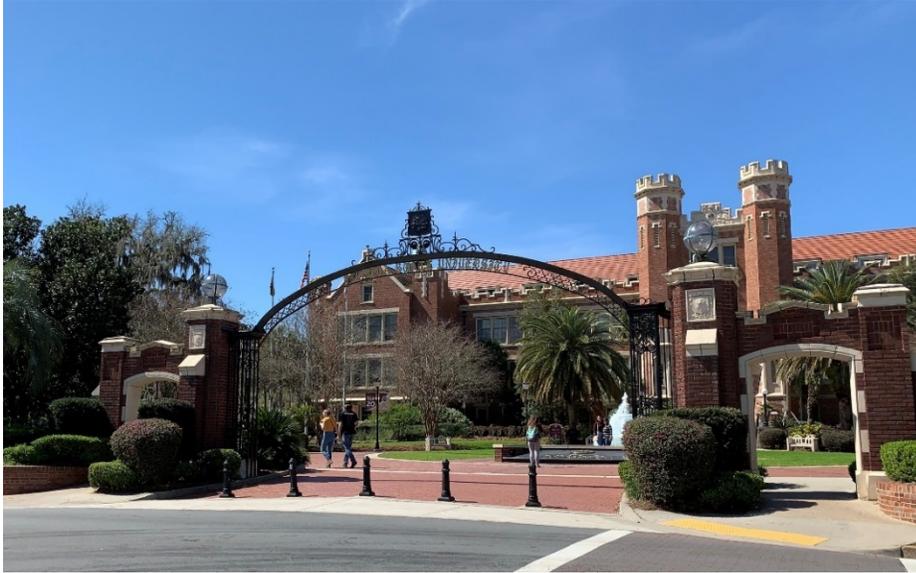
Photo 16.44 Gateways at College Avenue

- 1.d.2 Gateways:** Gateways play an important role as a ceremonial portal into the campus. The two historic gateways that exist on campus are at the Westcott Entrance on the east and “Southgate” (or Gilcrest Gate) on Jefferson Street. An implicit third gateway with the new EOAS building is at Woodward Avenue. A fourth gateway is on the campus edge to the west by the College of Medicine. Their importance as a symbol of access is reflected in professional design and attention to detail. See **Figure 3.1** and **Photo 16.44 and 16.45**.

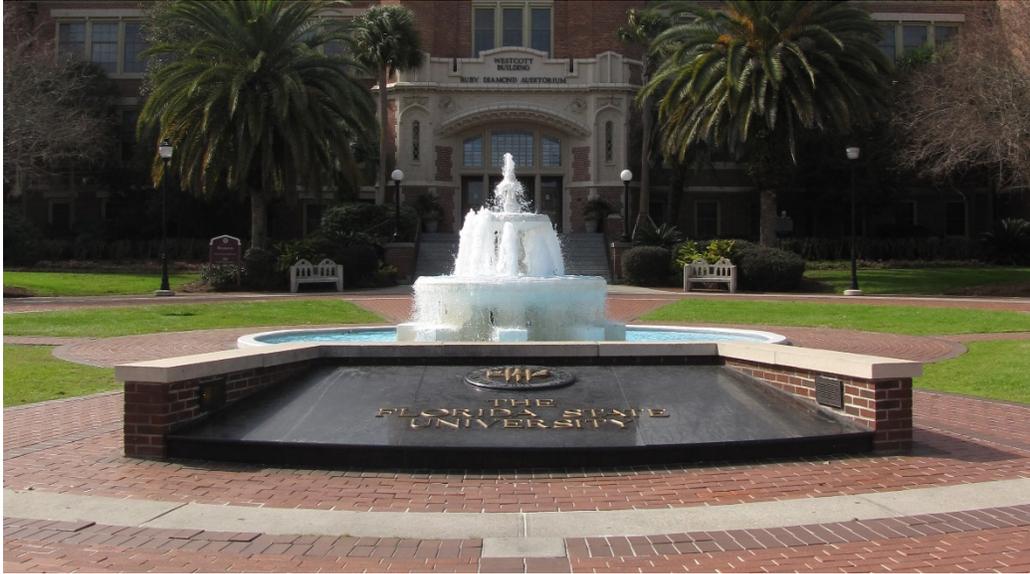
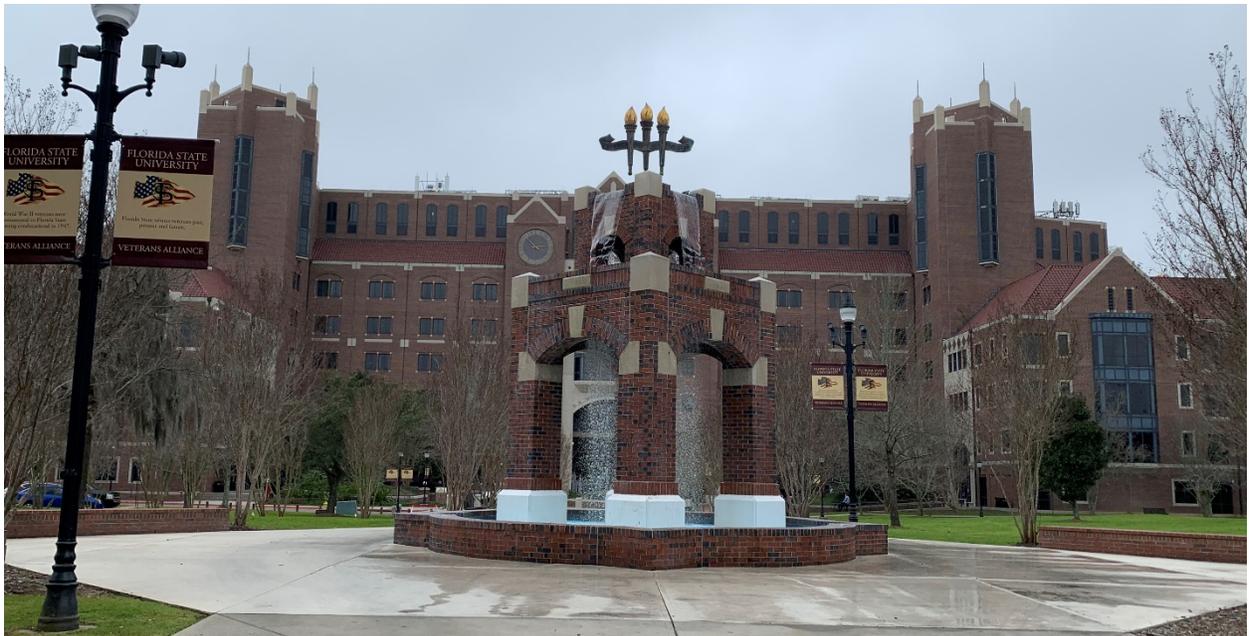
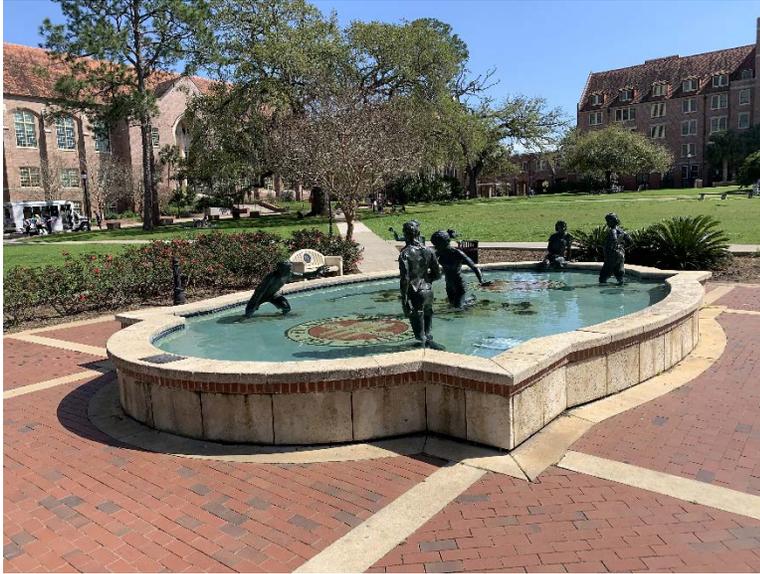
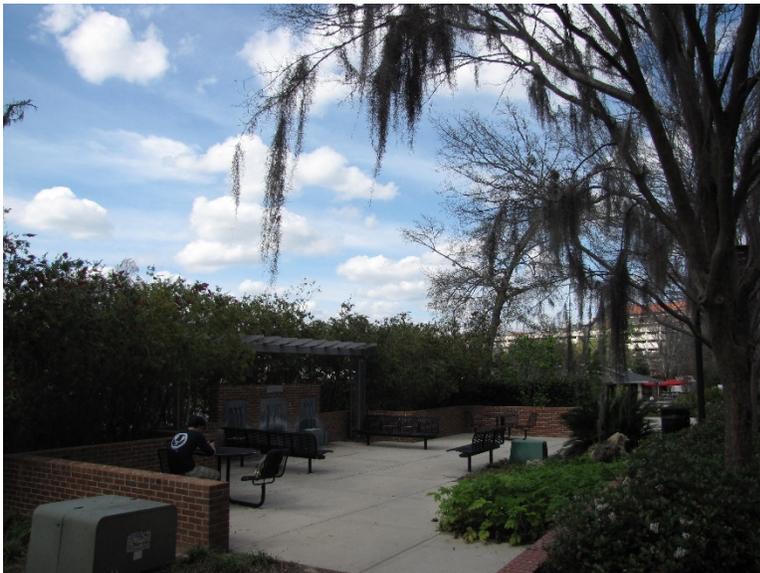
- 1.d.3 Fountains:** Fountains are found in four locations of campus. They are simple, pedestrian in scale, and add charm to their locations. However, maintenance costs are high. See **Photos 16.48 to 16.51**.
