Landscape Architectural Design Guidelines Supporting Data**1. Inventory and Analysis of Existing Conditions**

1.a. An inventory of the existing character, quality, and location of landscape treatments on the Tallahassee Campus are as follows:**1.a.1. Vehicular Circulation Routes:** Vehicular circulation routes on and around campus include:

16 Landscape Architectural Design Guidelines**Landscape Design Guidelines- Addition 2001****RE:** Advanced Inventory and Analysis of Existing Conditions**The Institutional Landscape of Florida State University:**

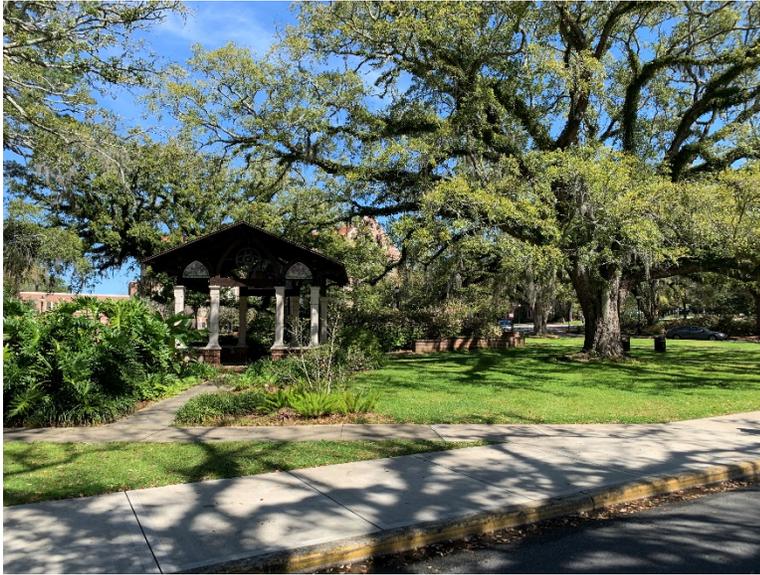
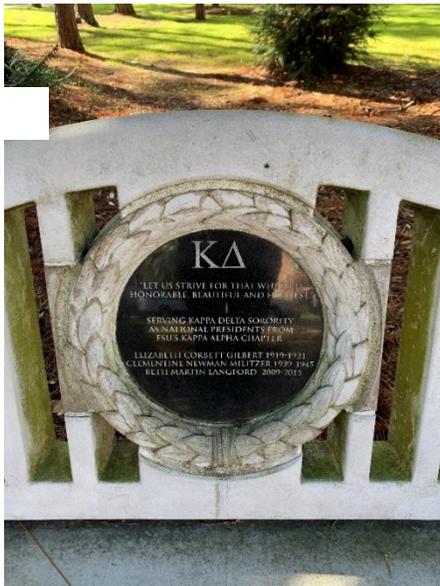
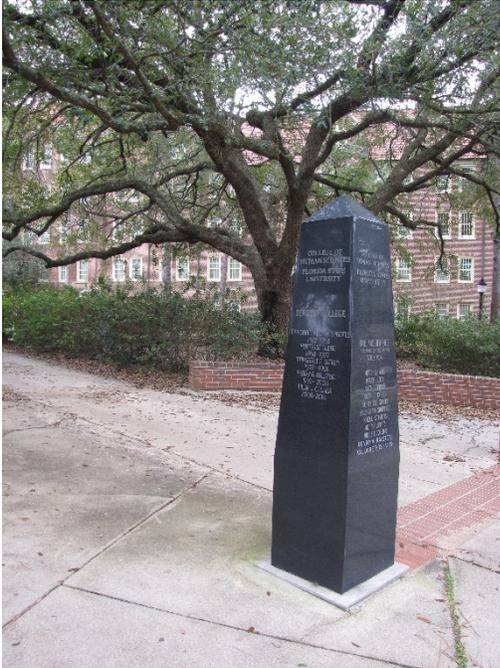
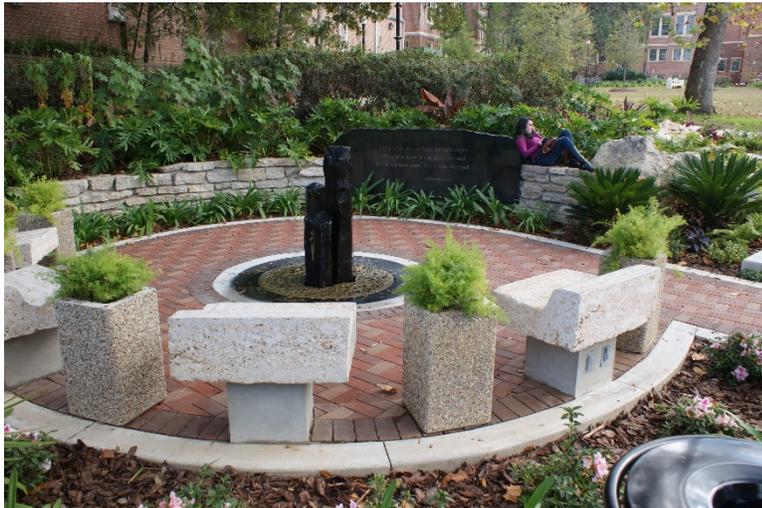
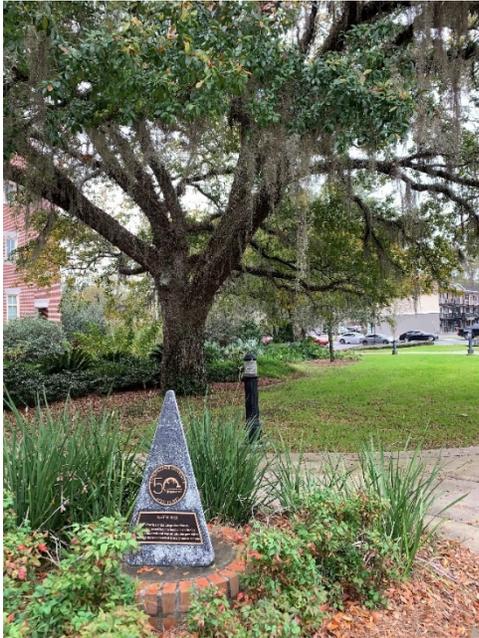
- 1.d.4 Memorials:** Memorials are found in several locations on campus. Their nature range from a memorial statue to plaques, sundials, benches, etc. See **Photos 16.52 to 16.56**. Siting of memorials should be well thought out so they are not imposing on the landscape.

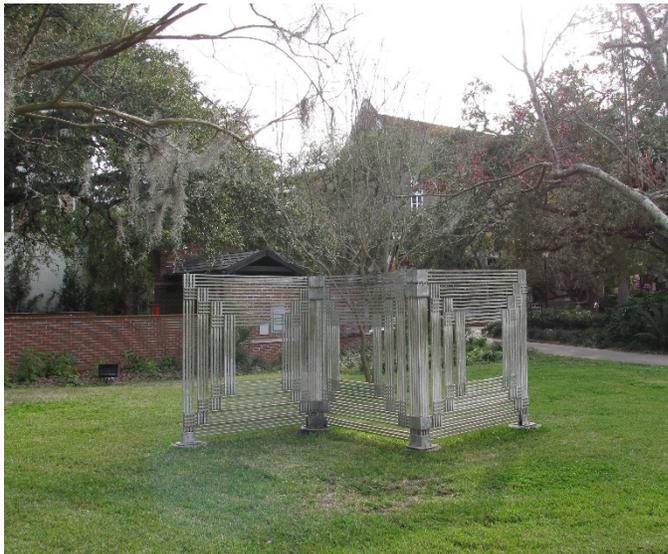
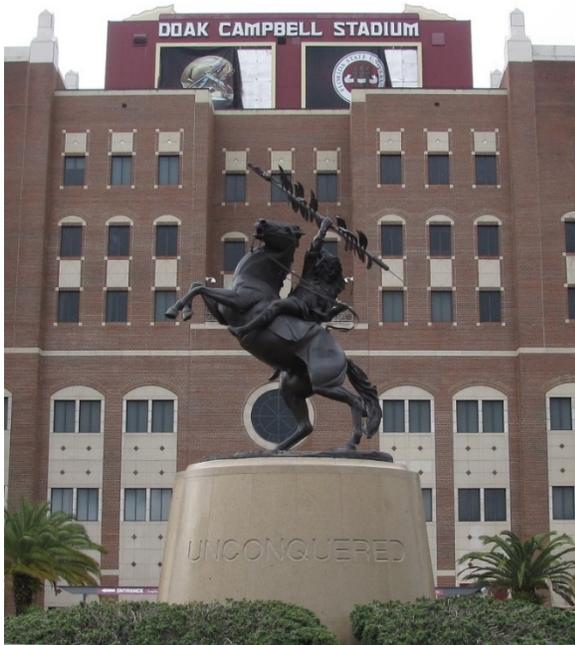
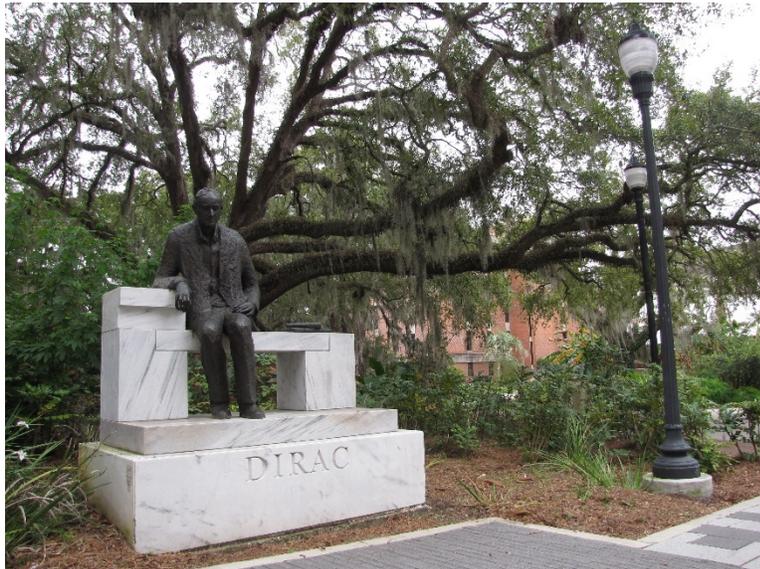
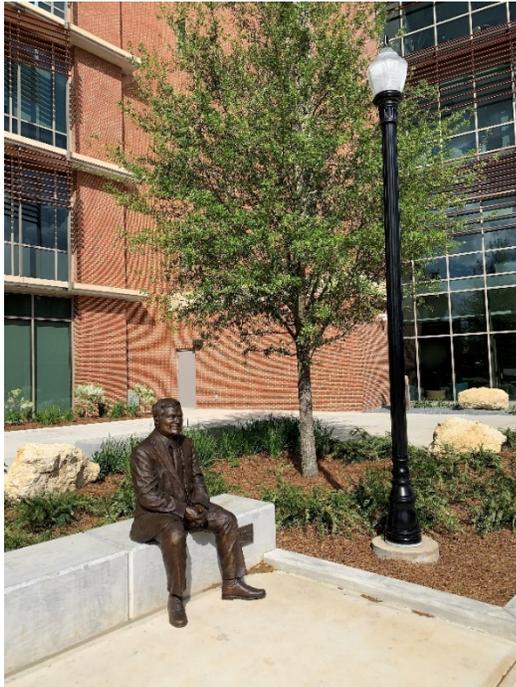
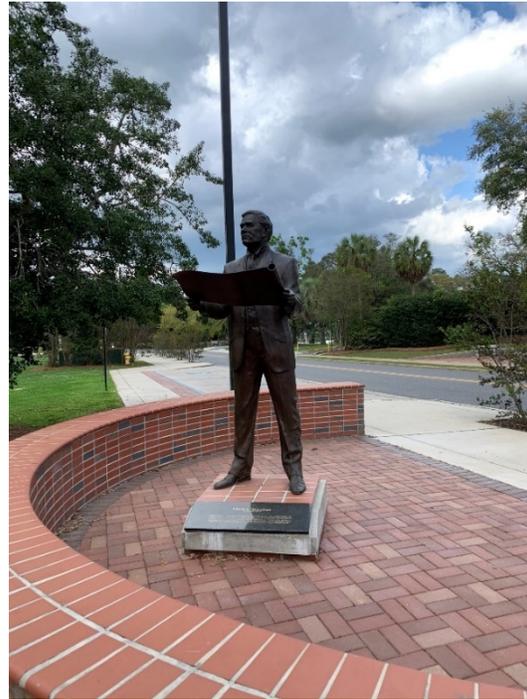
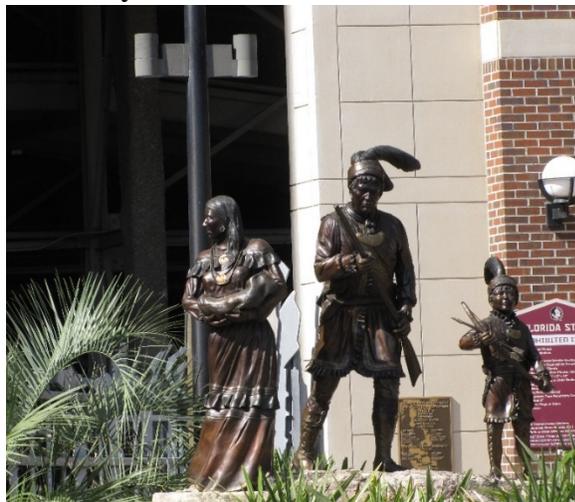
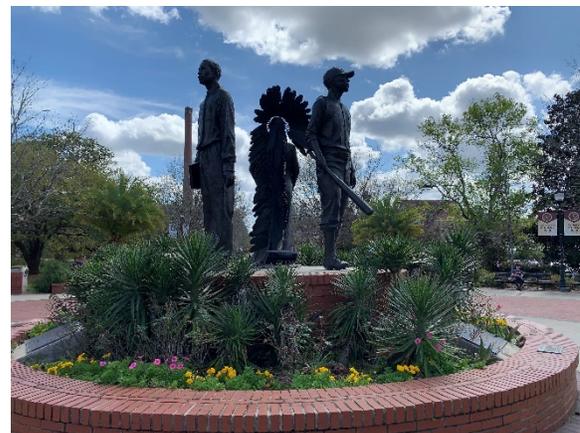
- 1.d.5 Sculpture:** Sculpture occurs in many locations on campus. It adds a richness to a campus space and creates visual interest. Careful selection and placement on campus of high-quality pieces of sculpture should be encouraged, particularly if expertise is provided as has been the case with existing works by the curators of the pieces who are familiar with the art. See **Figure 3.16** and **Photos 16.57 to 16.63**.
