# FLORIDA STATE UNIVERSITY

## HOFFMAN (KATHERINE B) TEACH LAB

FACILITY CONDITION ANALYSIS

RE-INSPECTION DATE: MAY 10, 2012

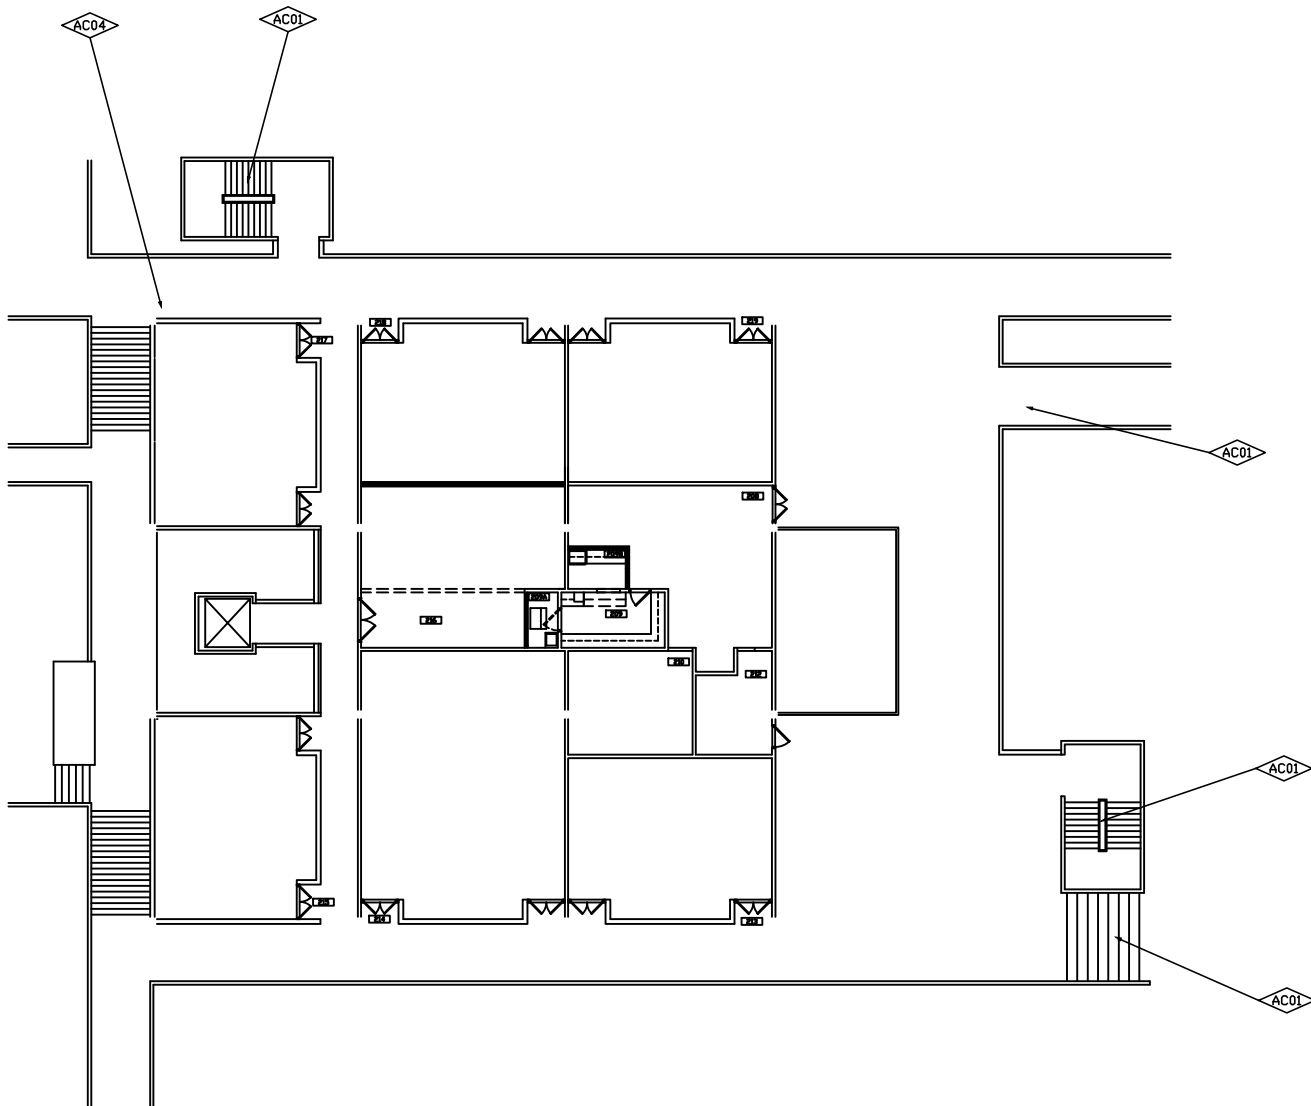
FIRST  
FLOOR  
PLAN

- AC03   AC05   EL02   EL03   EL04   FS01
- IS01   IS02   IS03   HV01   PL01   PL04
- PL05

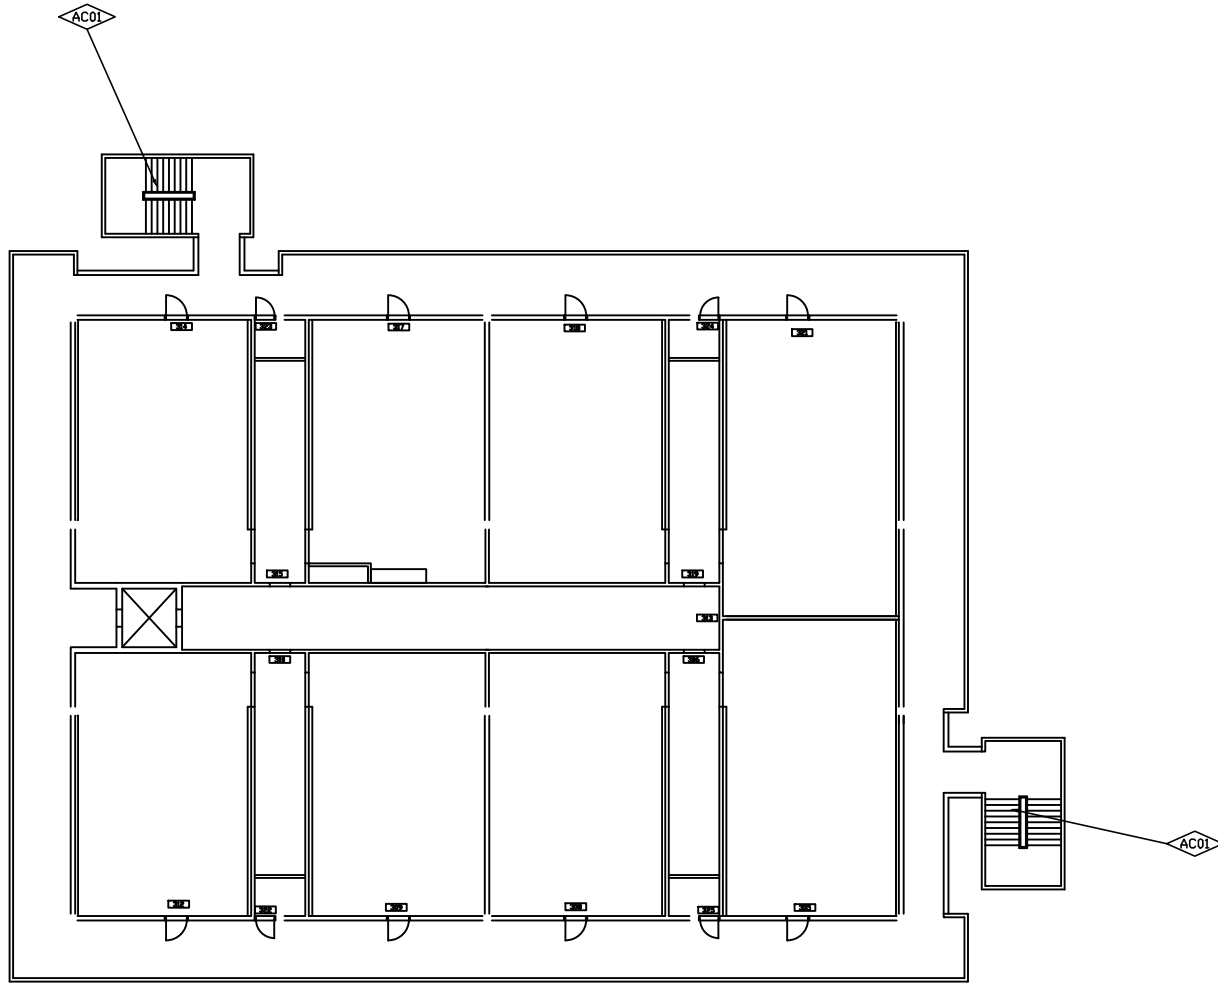
SECOND  
FLOOR  
PLAN

- AC03
- AC05
- EL02
- EL04
- FS01
- IS01
- IS02
- IS03
- PL01
- PL04
- PL05

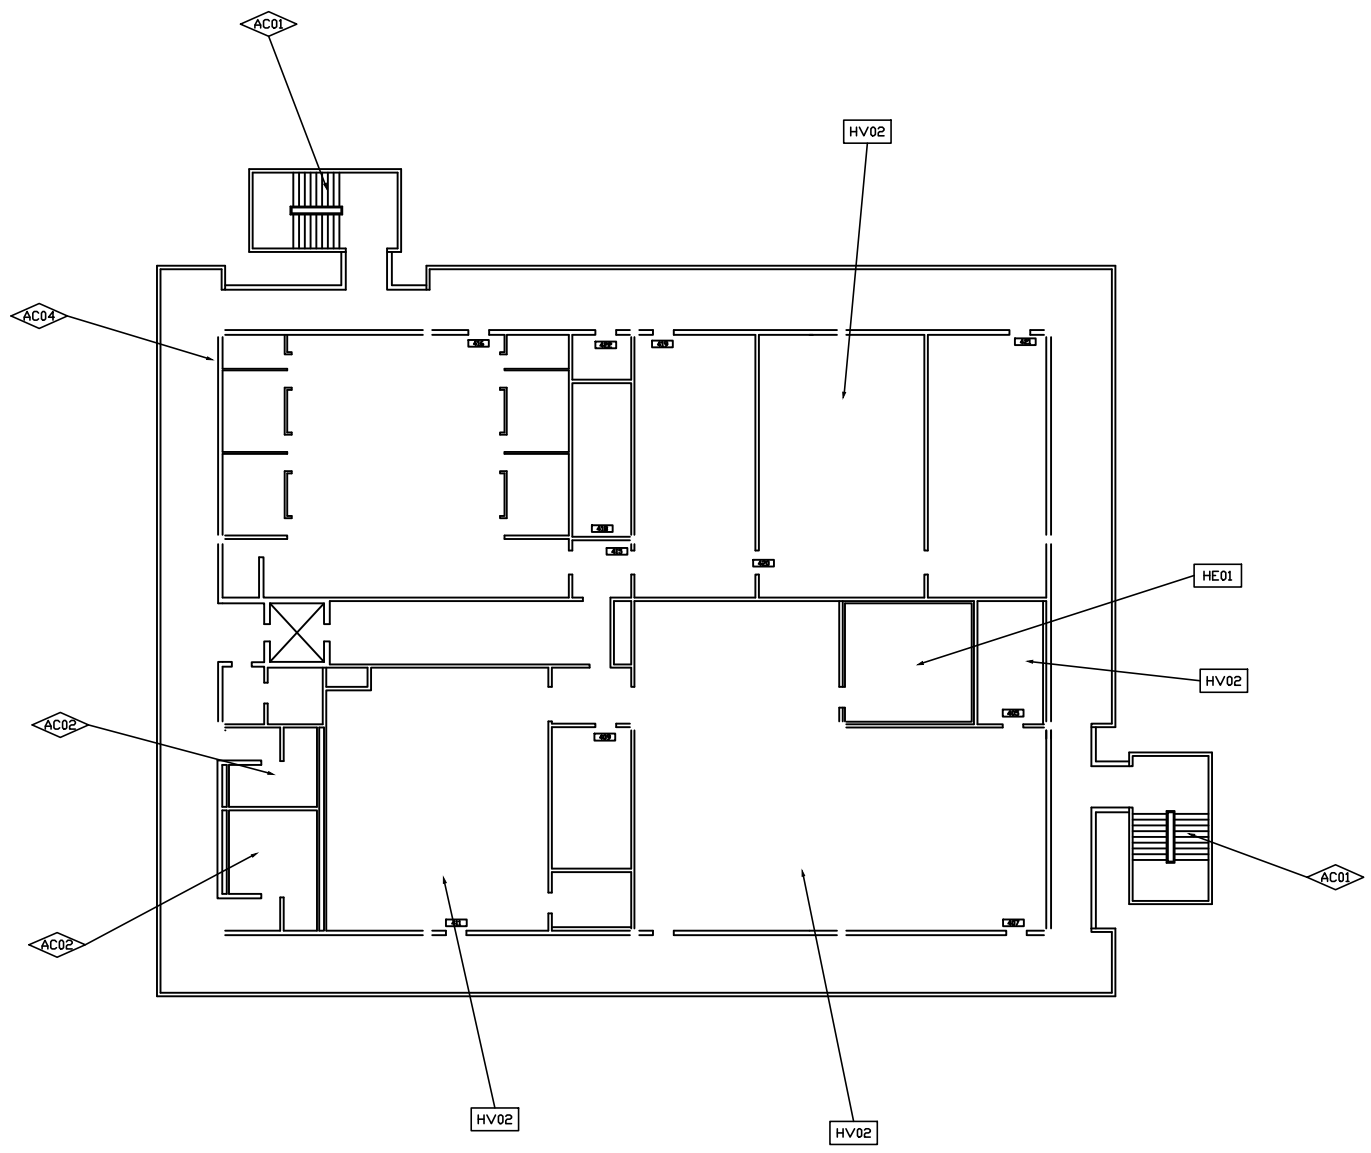
THIRD  
FLOOR  
PLAN

| AC03 | AC05 | EL02 | EL04 | FS01 | IS01 |

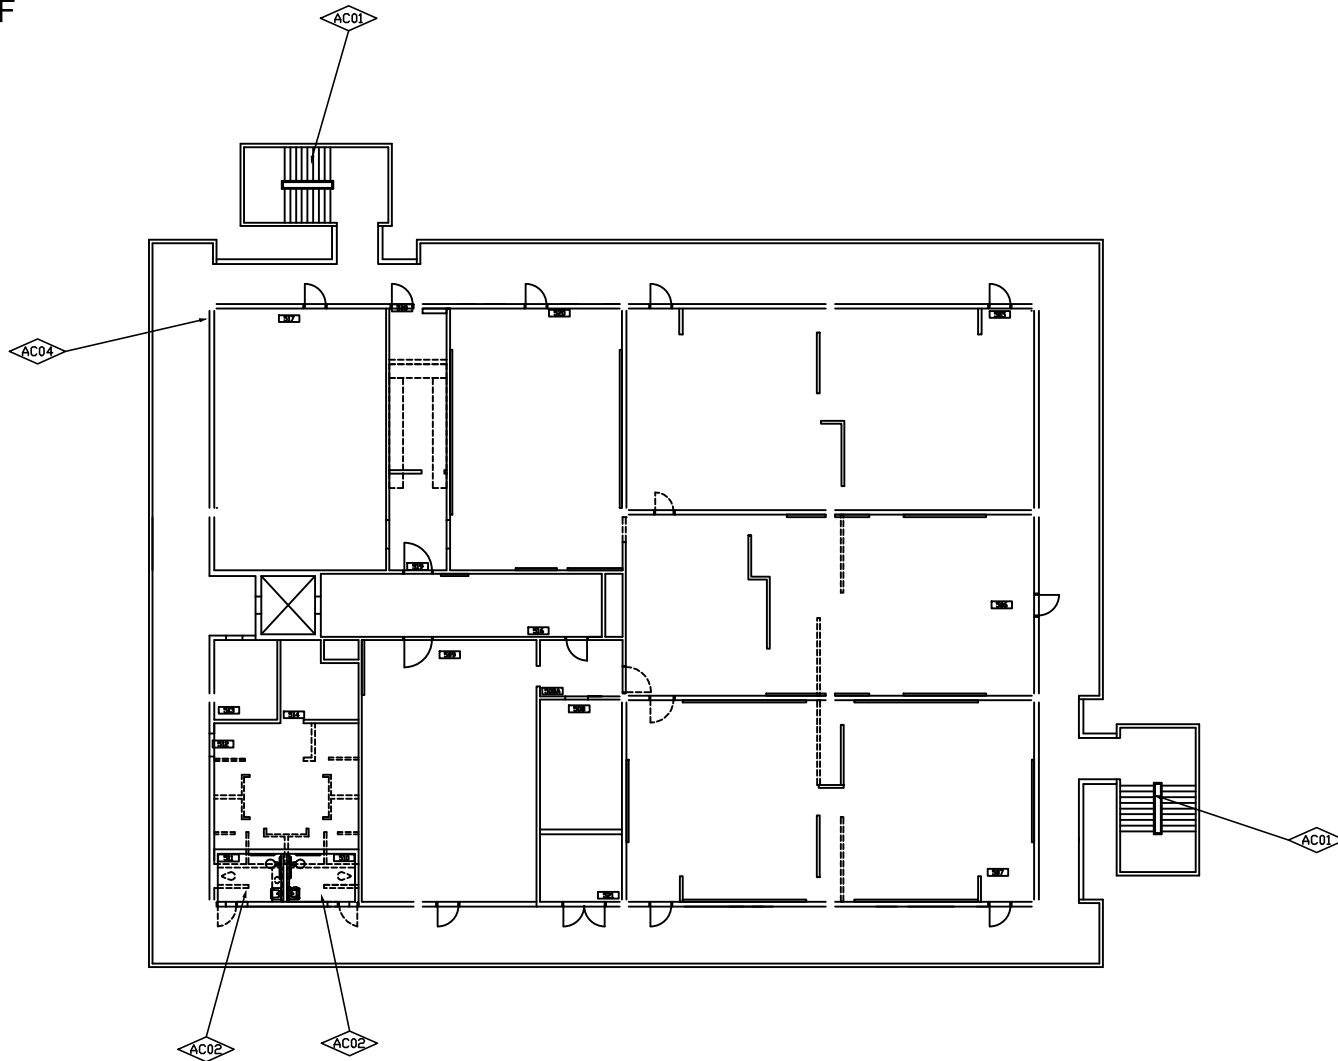
## FOURTH FLOOR PLAN

ROOF  
HV01

- AC03
- AC05
- EL02
- EL04
- FS01
- IS01
- IS02
- IS03
- PL01
- PL04
- PL05

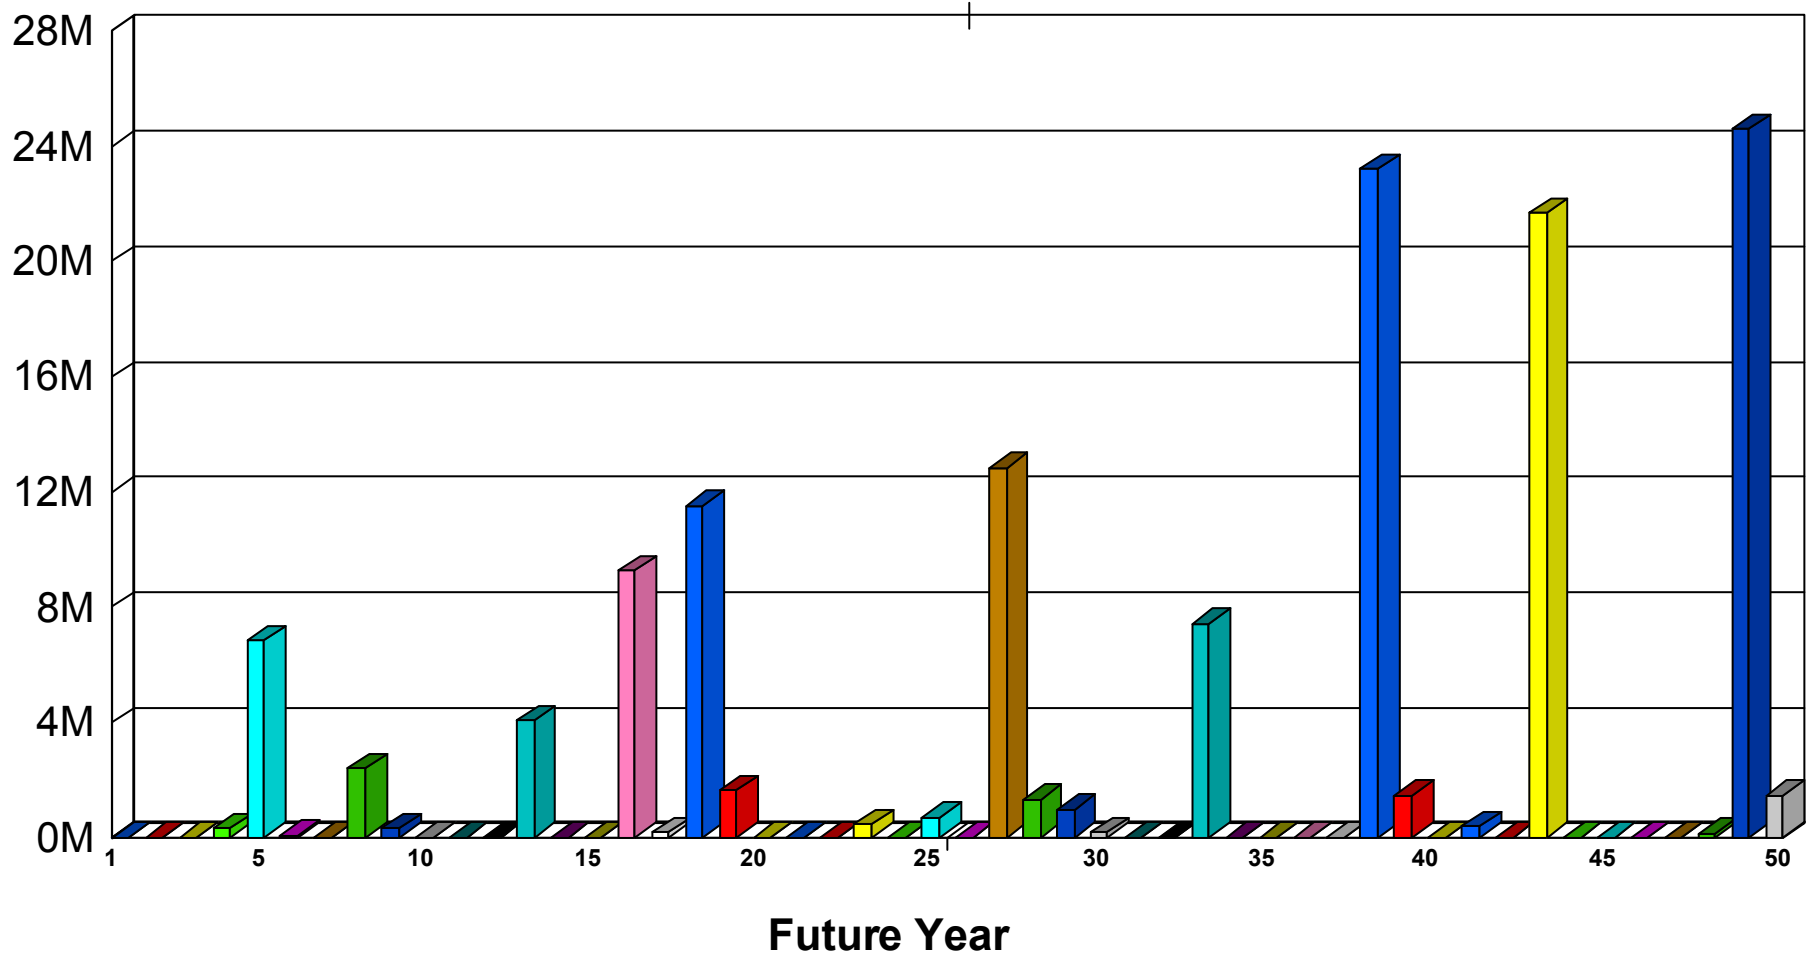
# Life Cycle Model Expenditure Projections

Average Annual Renewal Cost per SqFt \$13.95
